6797/Jones Library, Amherst

October 24, 2023

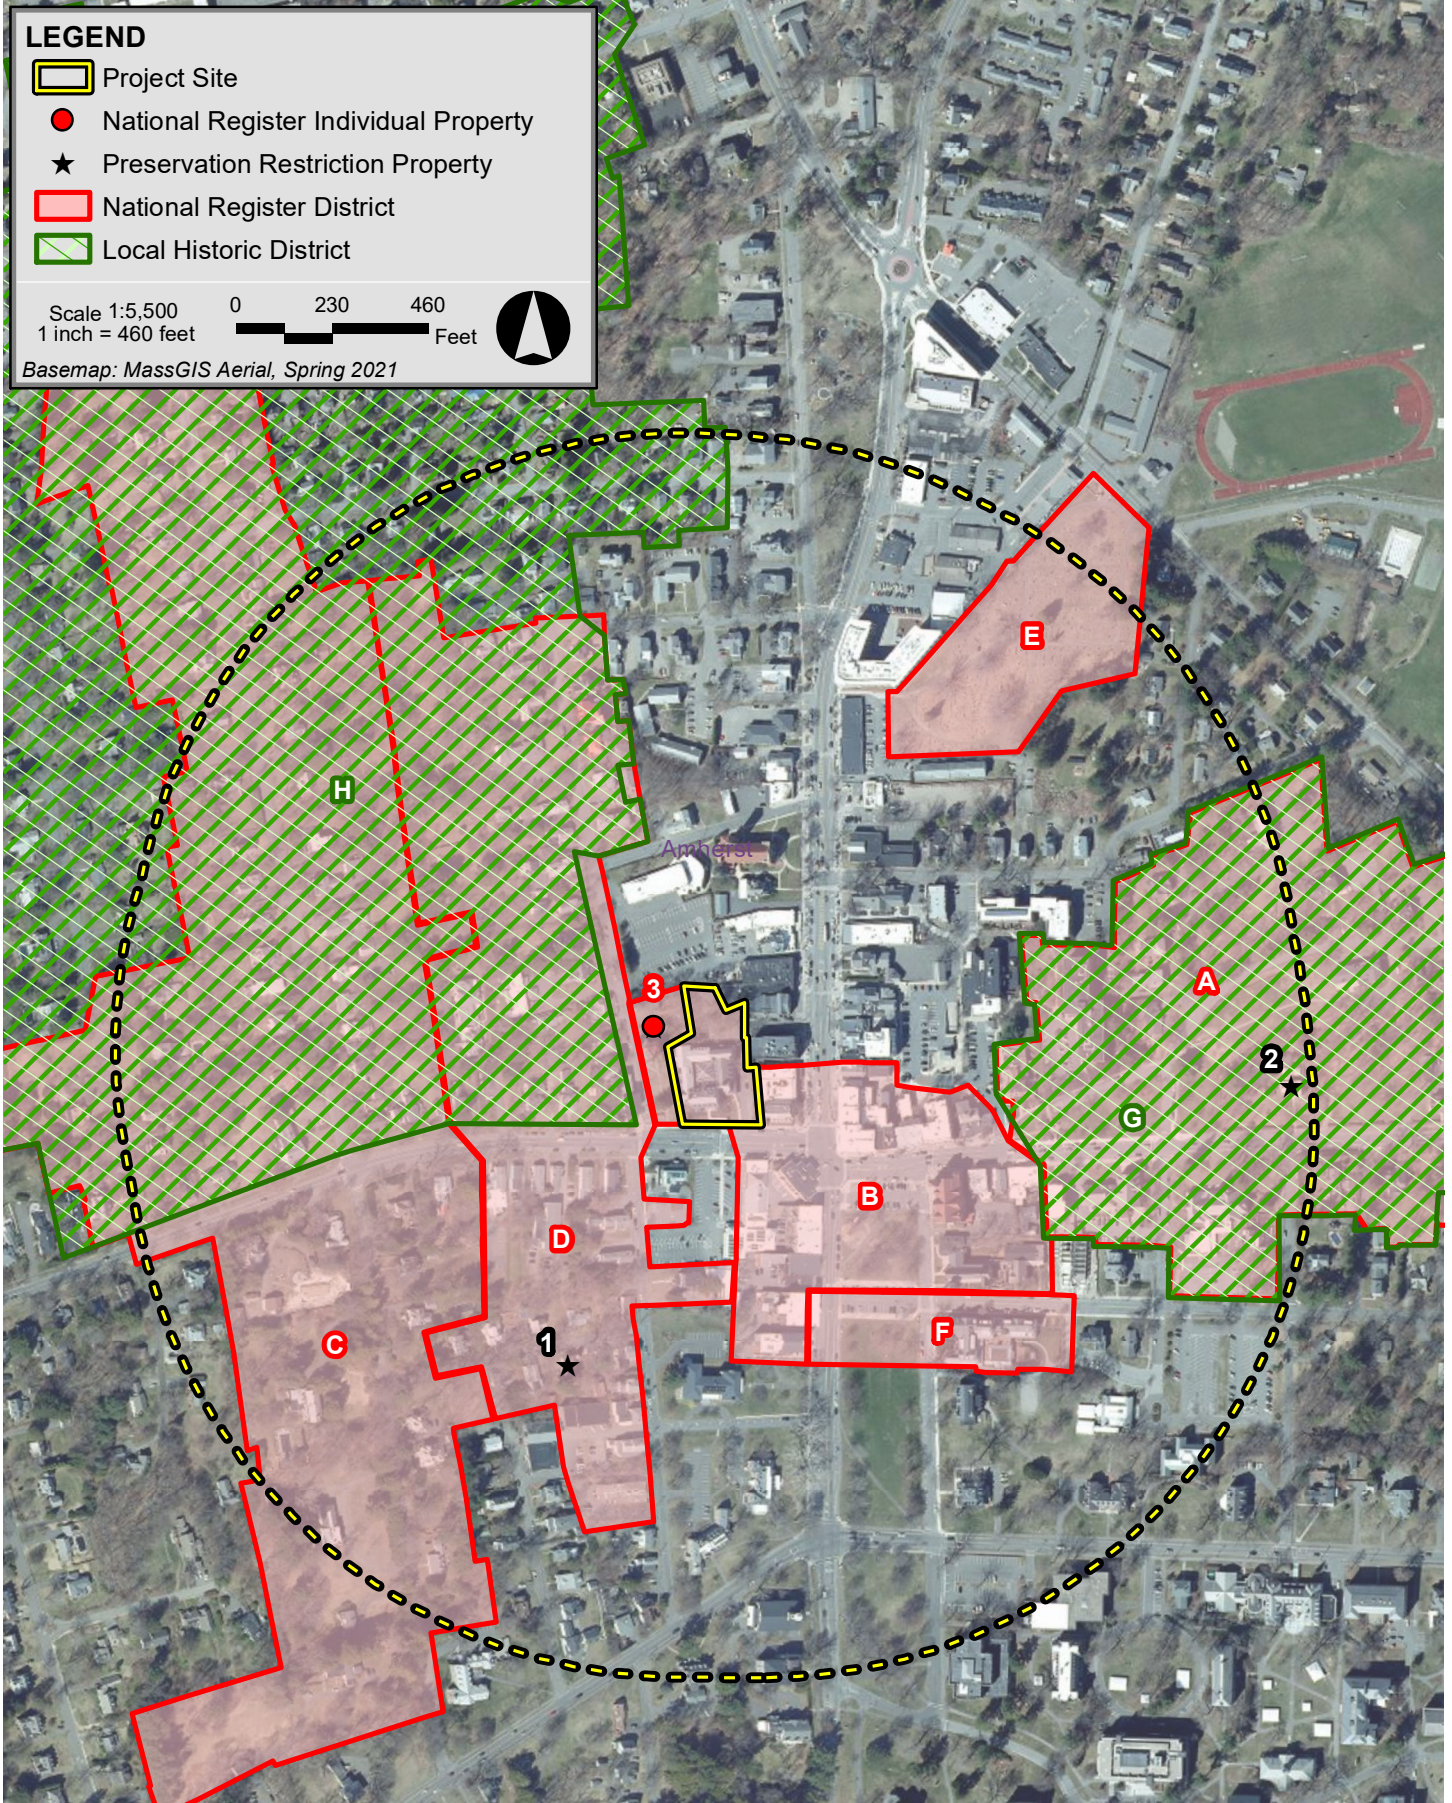
43 Amity Street Amherst, Massachusetts

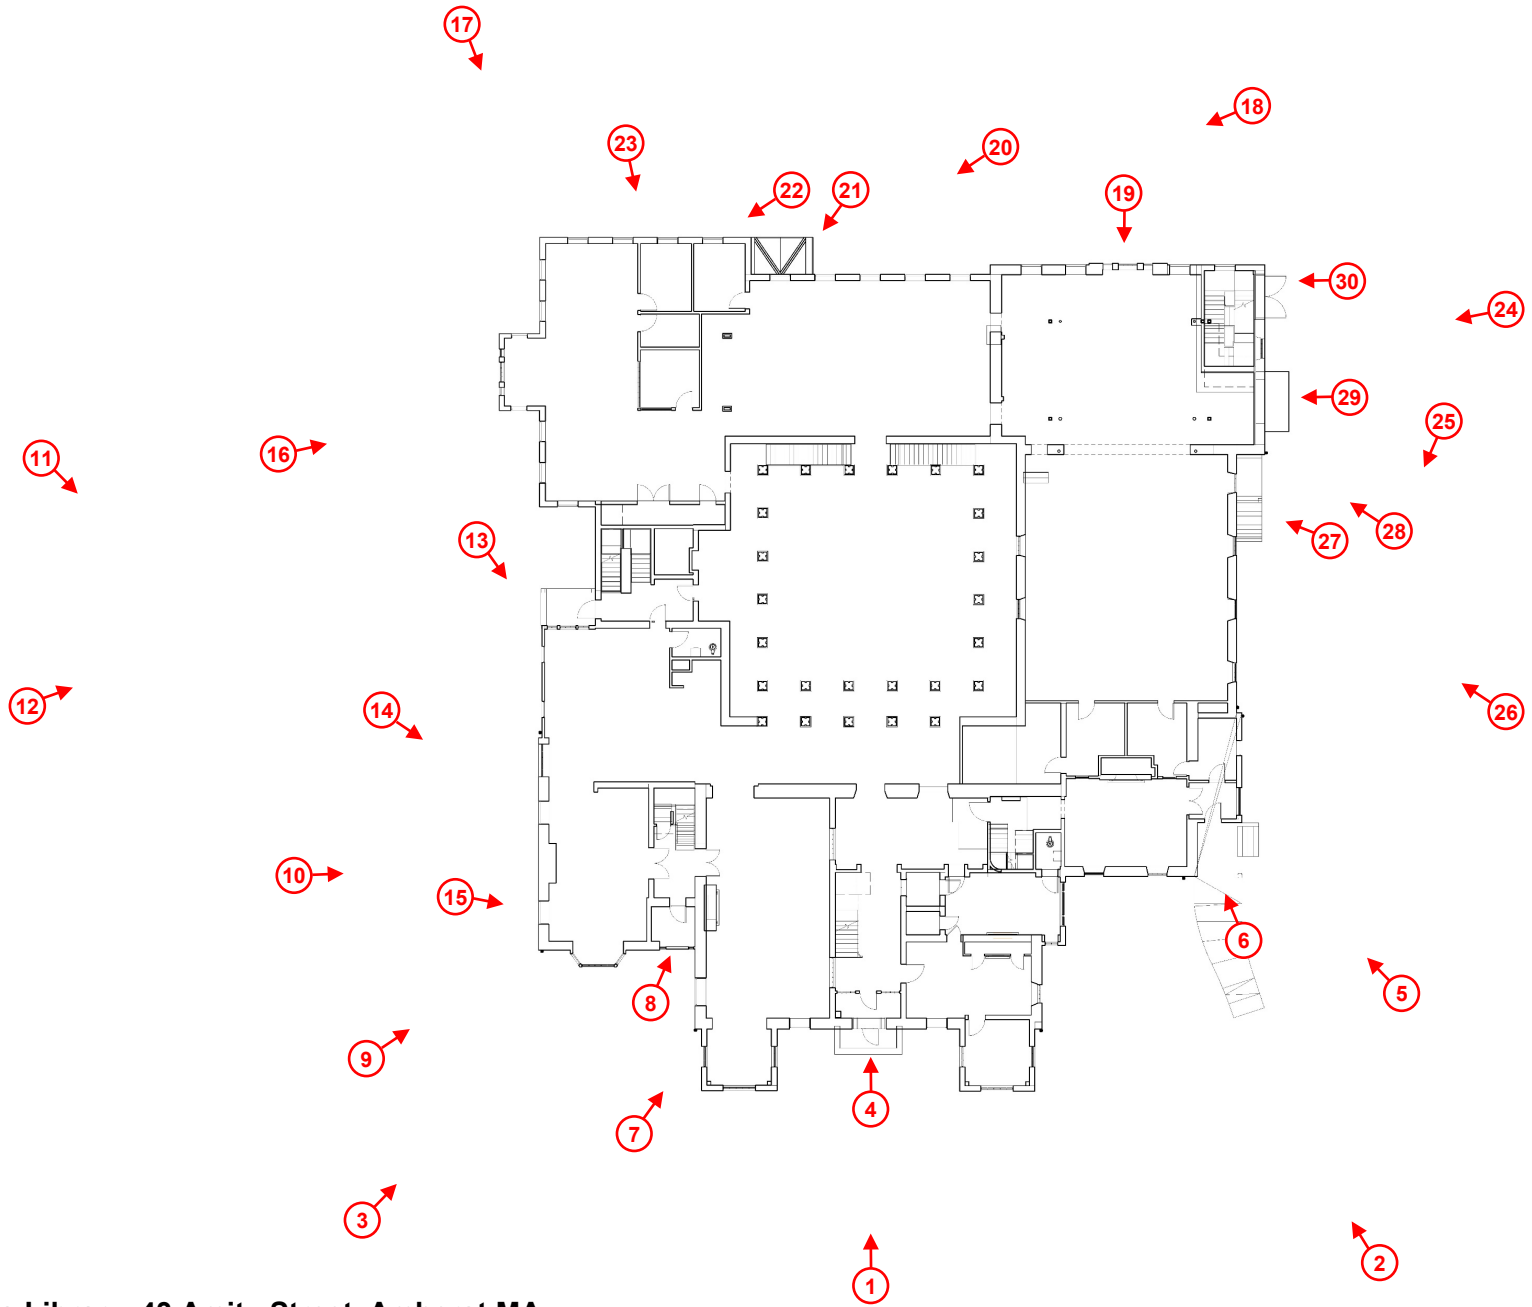
Jones Library, 43 Amity Street, Amherst MA

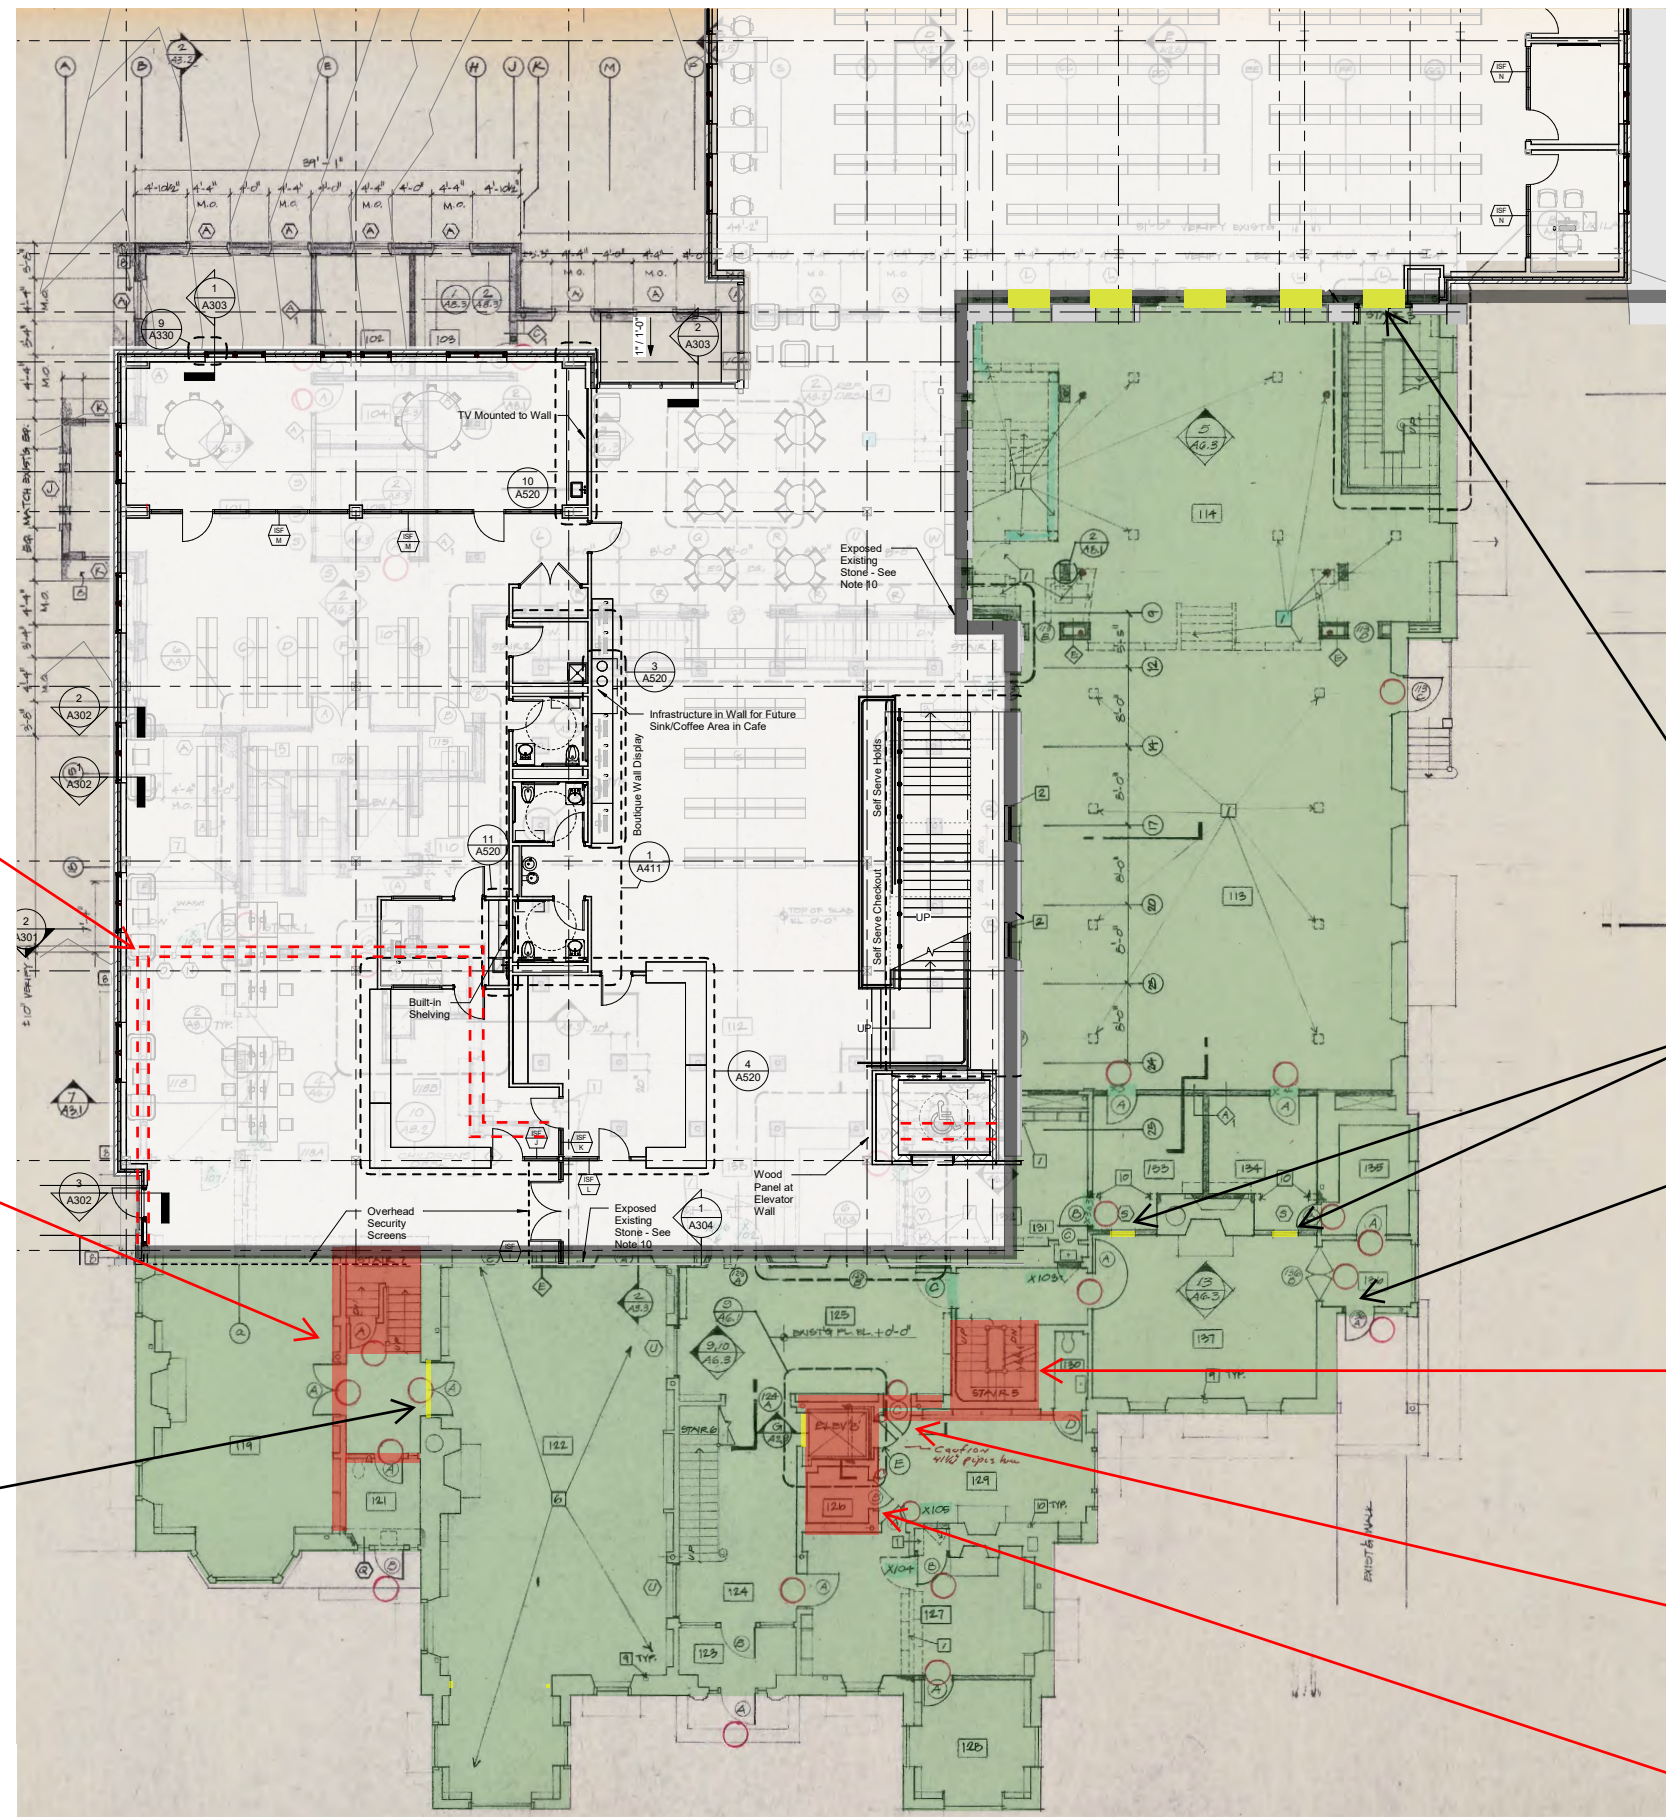
**1927 Historic elements to remain**

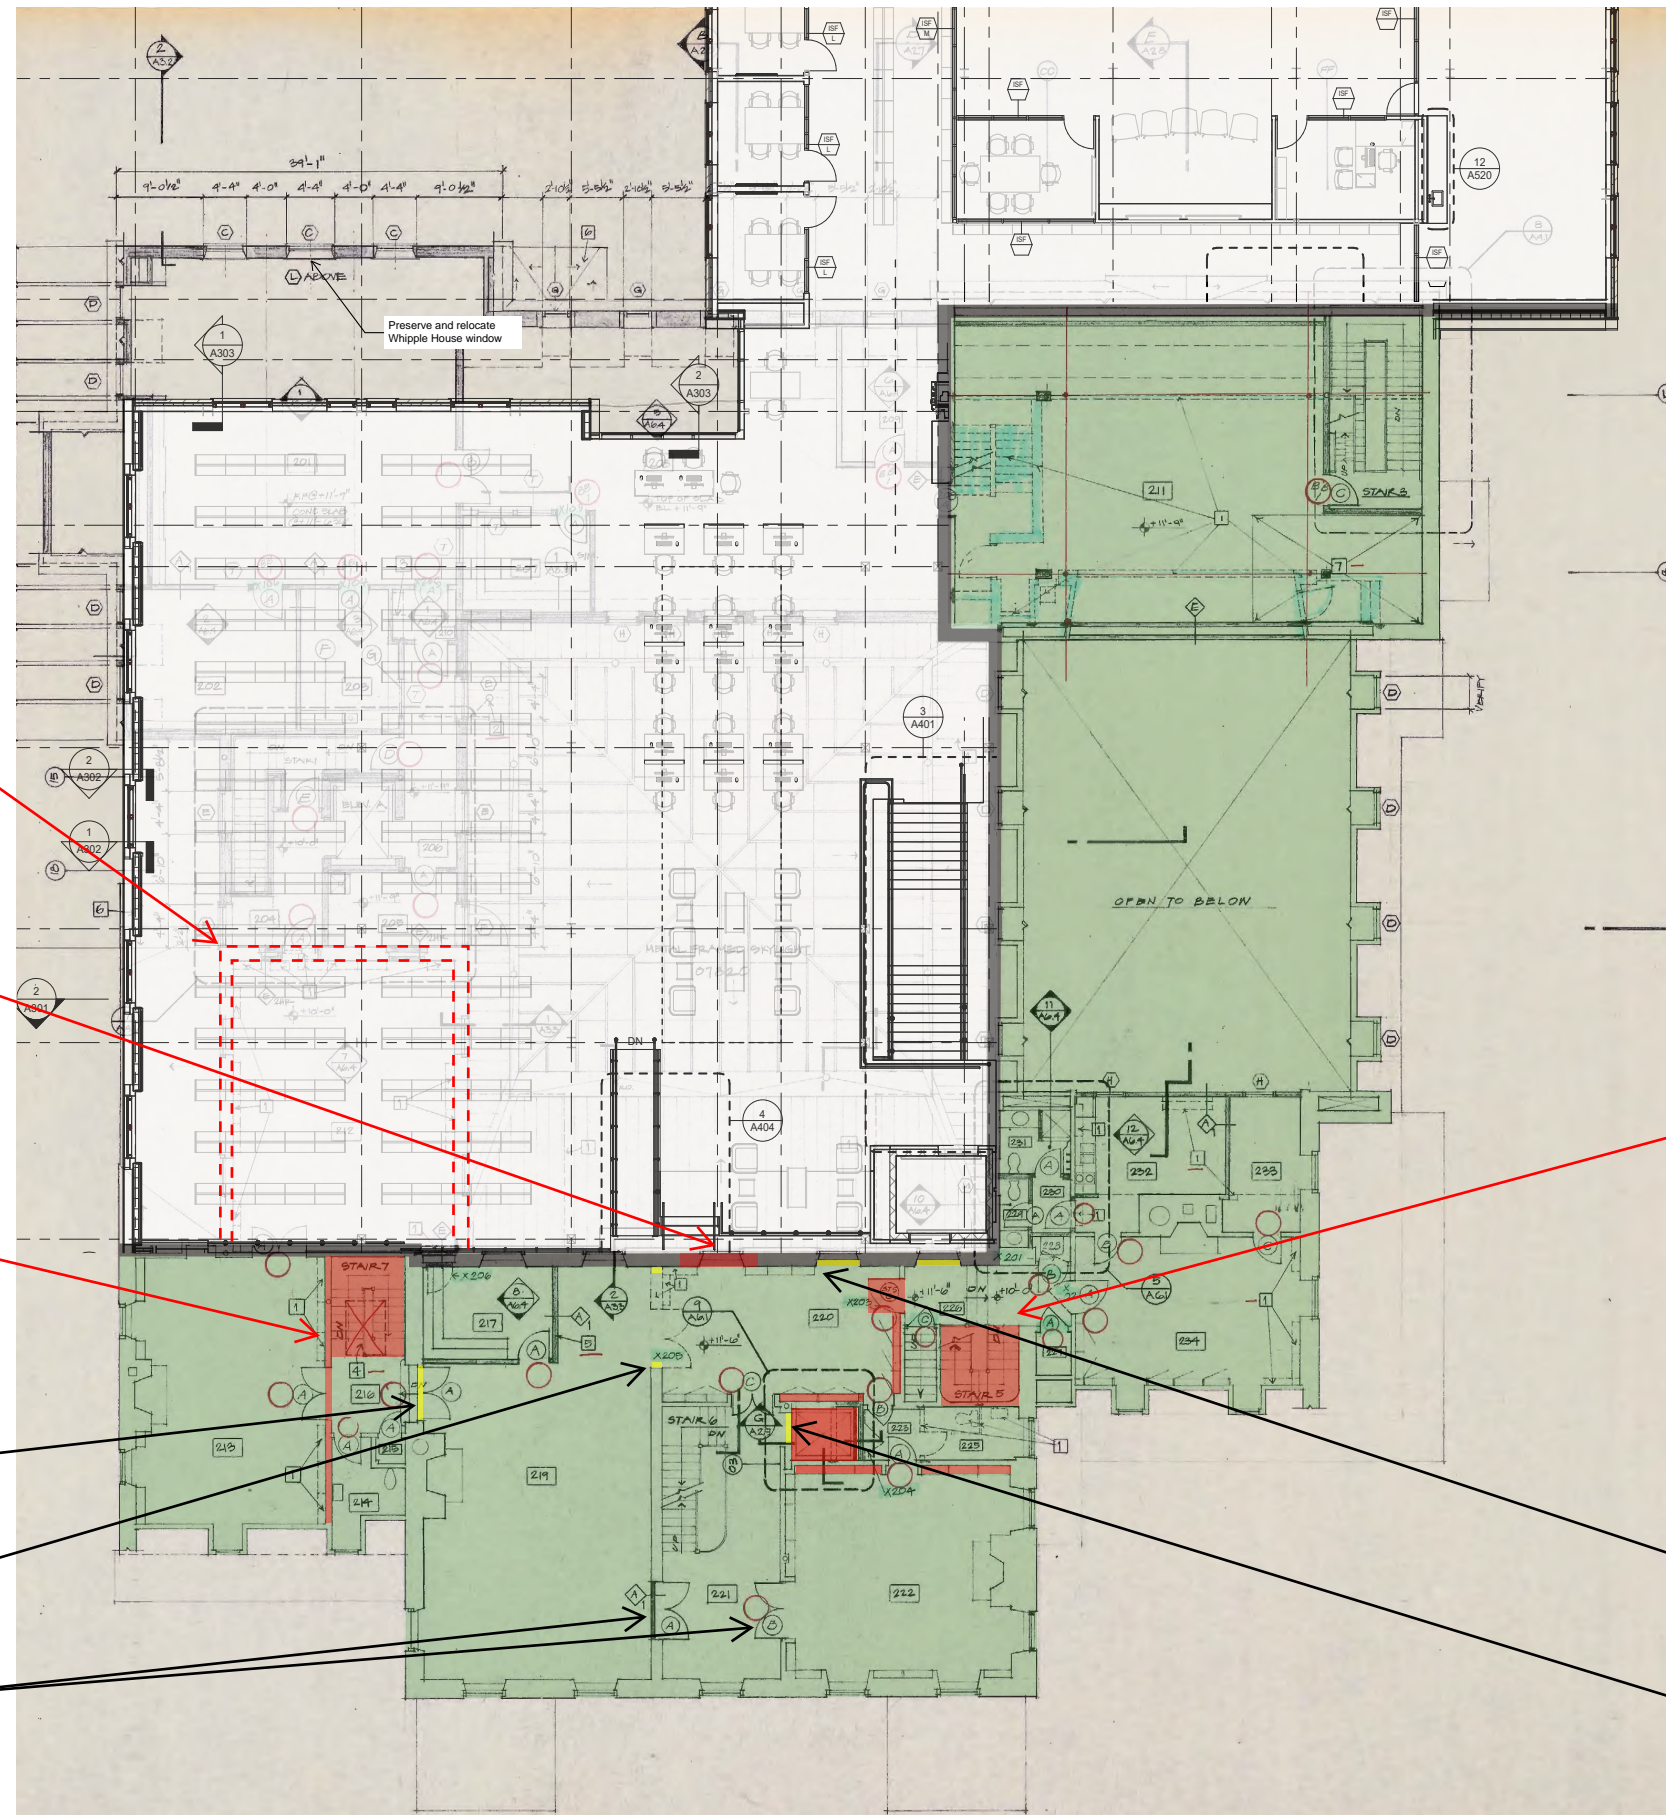
Existing stair does not meet code: the riser height exceeds 7", the guard height is more than 12" too low, a 4" sphere can pass through guard, and the handrail profile is non-compliant.

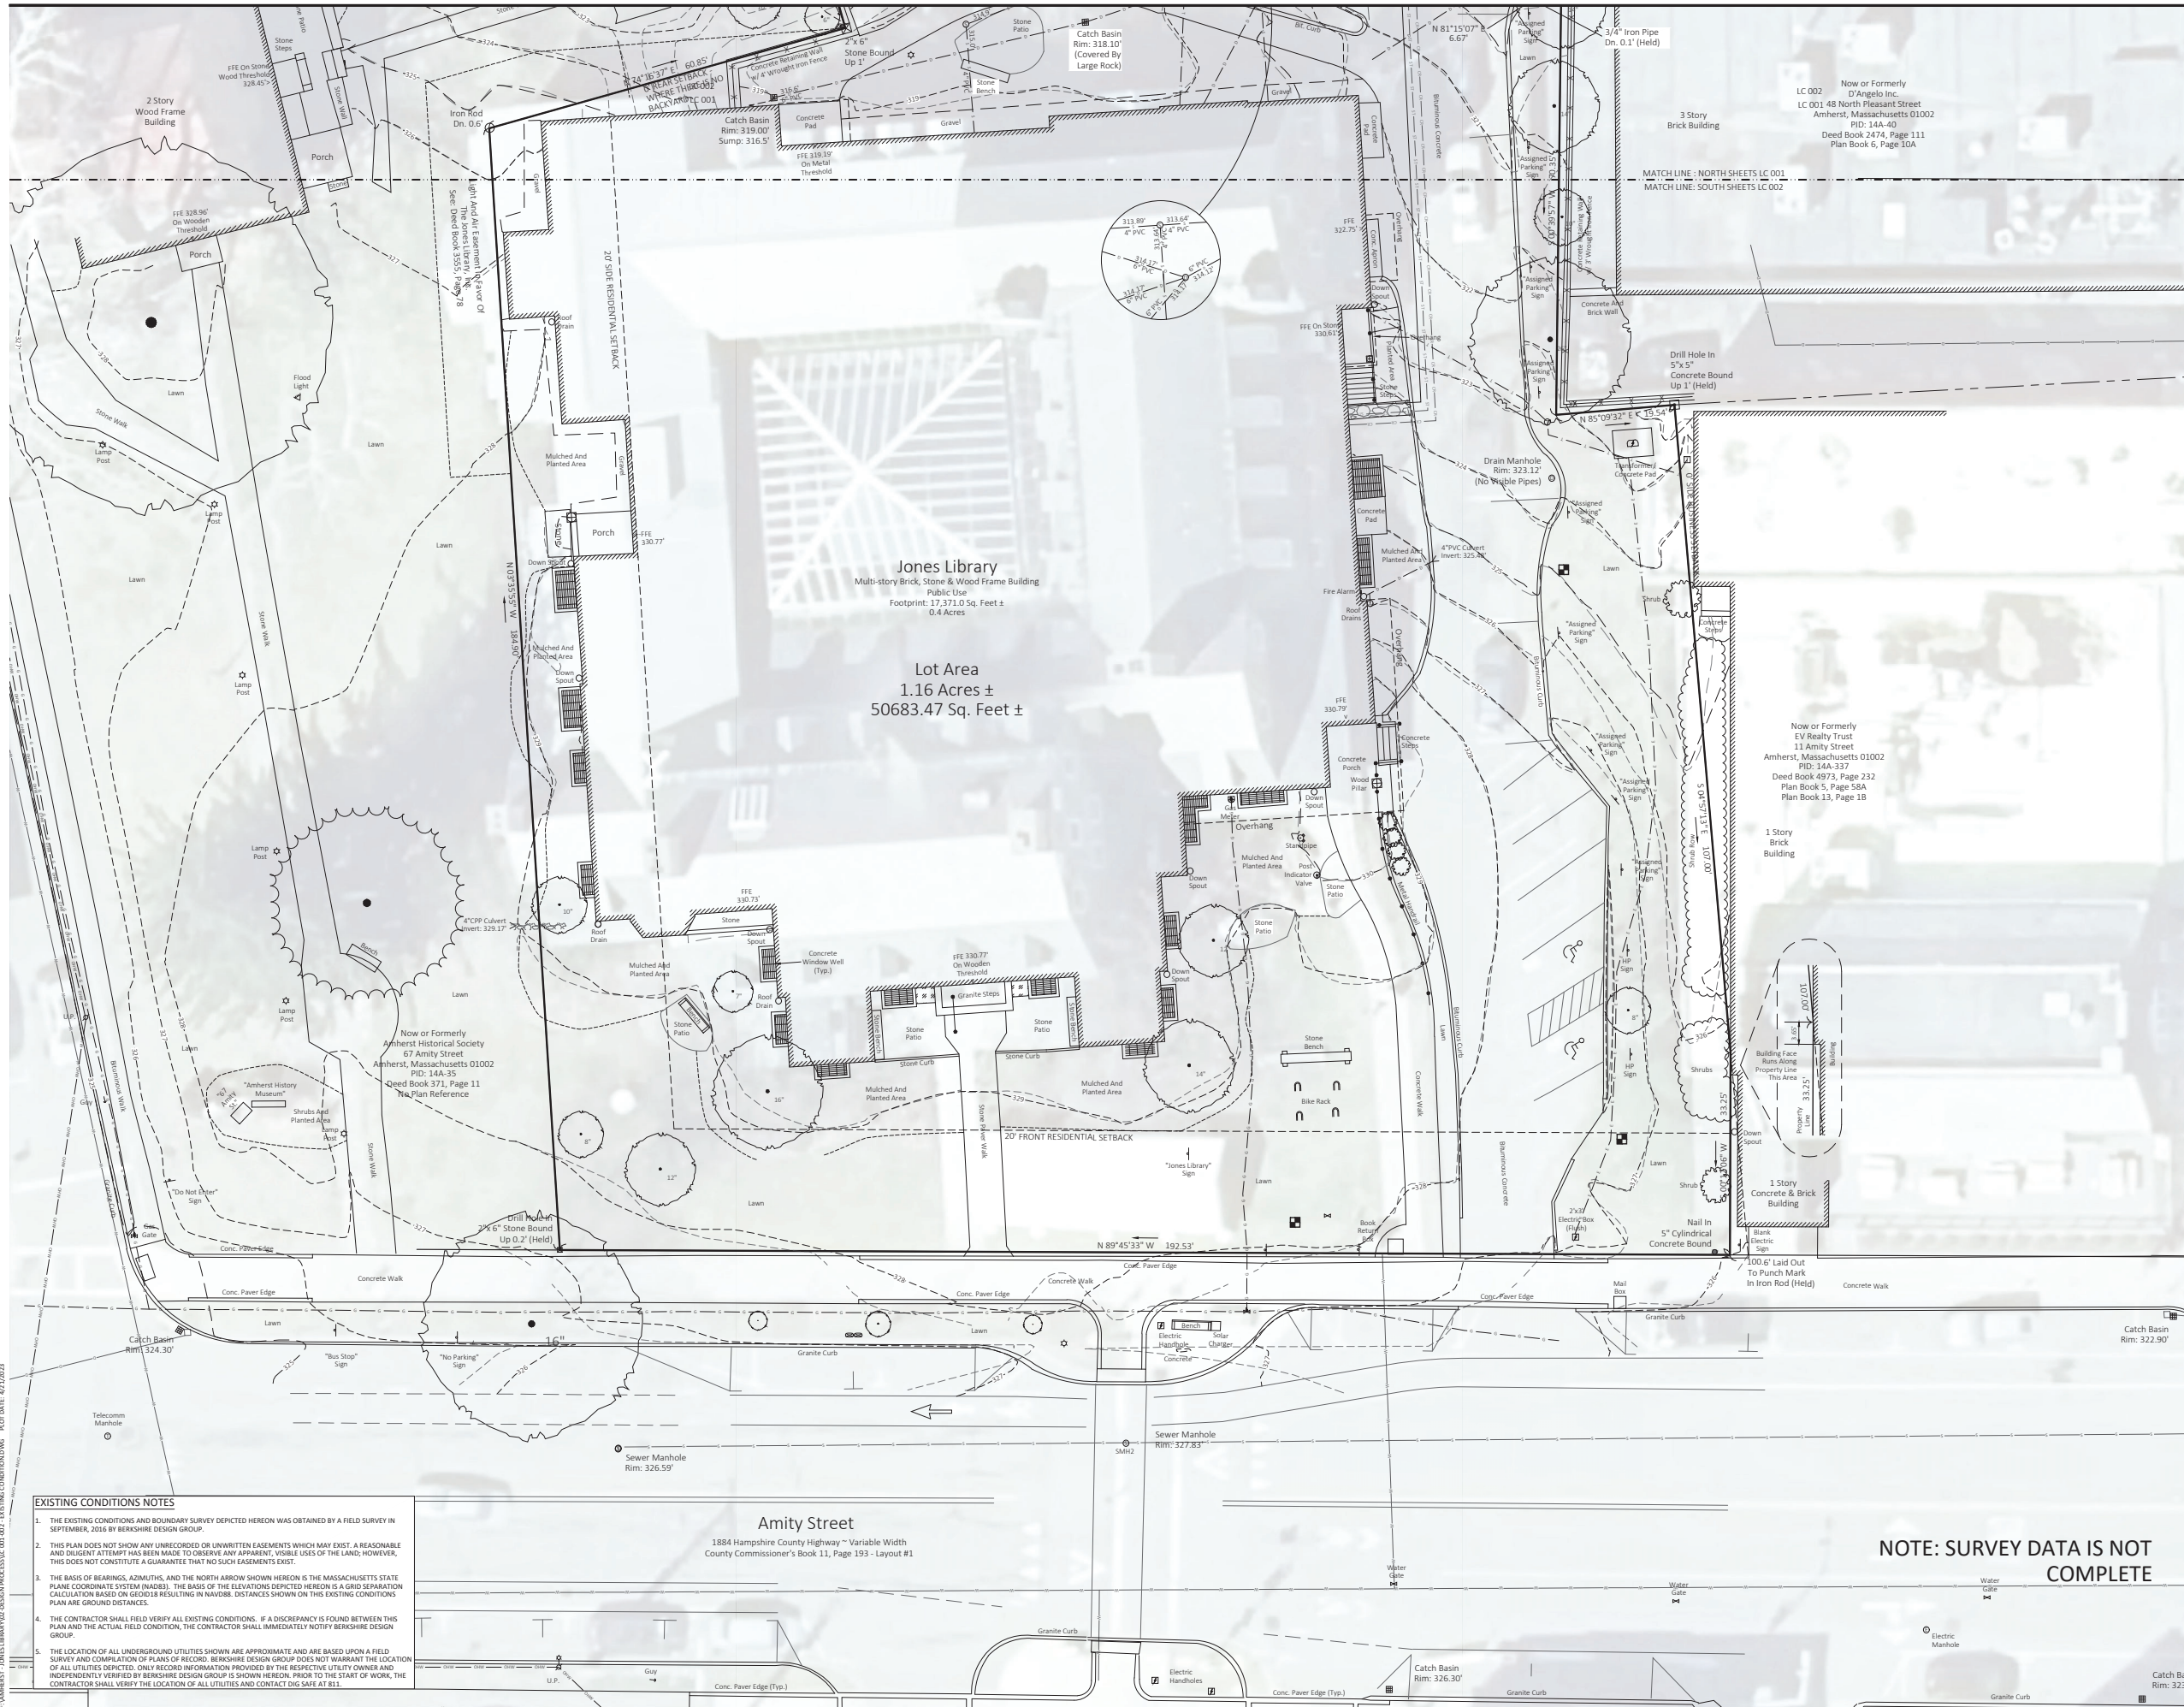
1. AMHERST - JONES LIBRARY DESIGN PROCESS (LC-001) - EXISTING CONDITIONS PLAN - SOUTH DATE: 4/21/2023

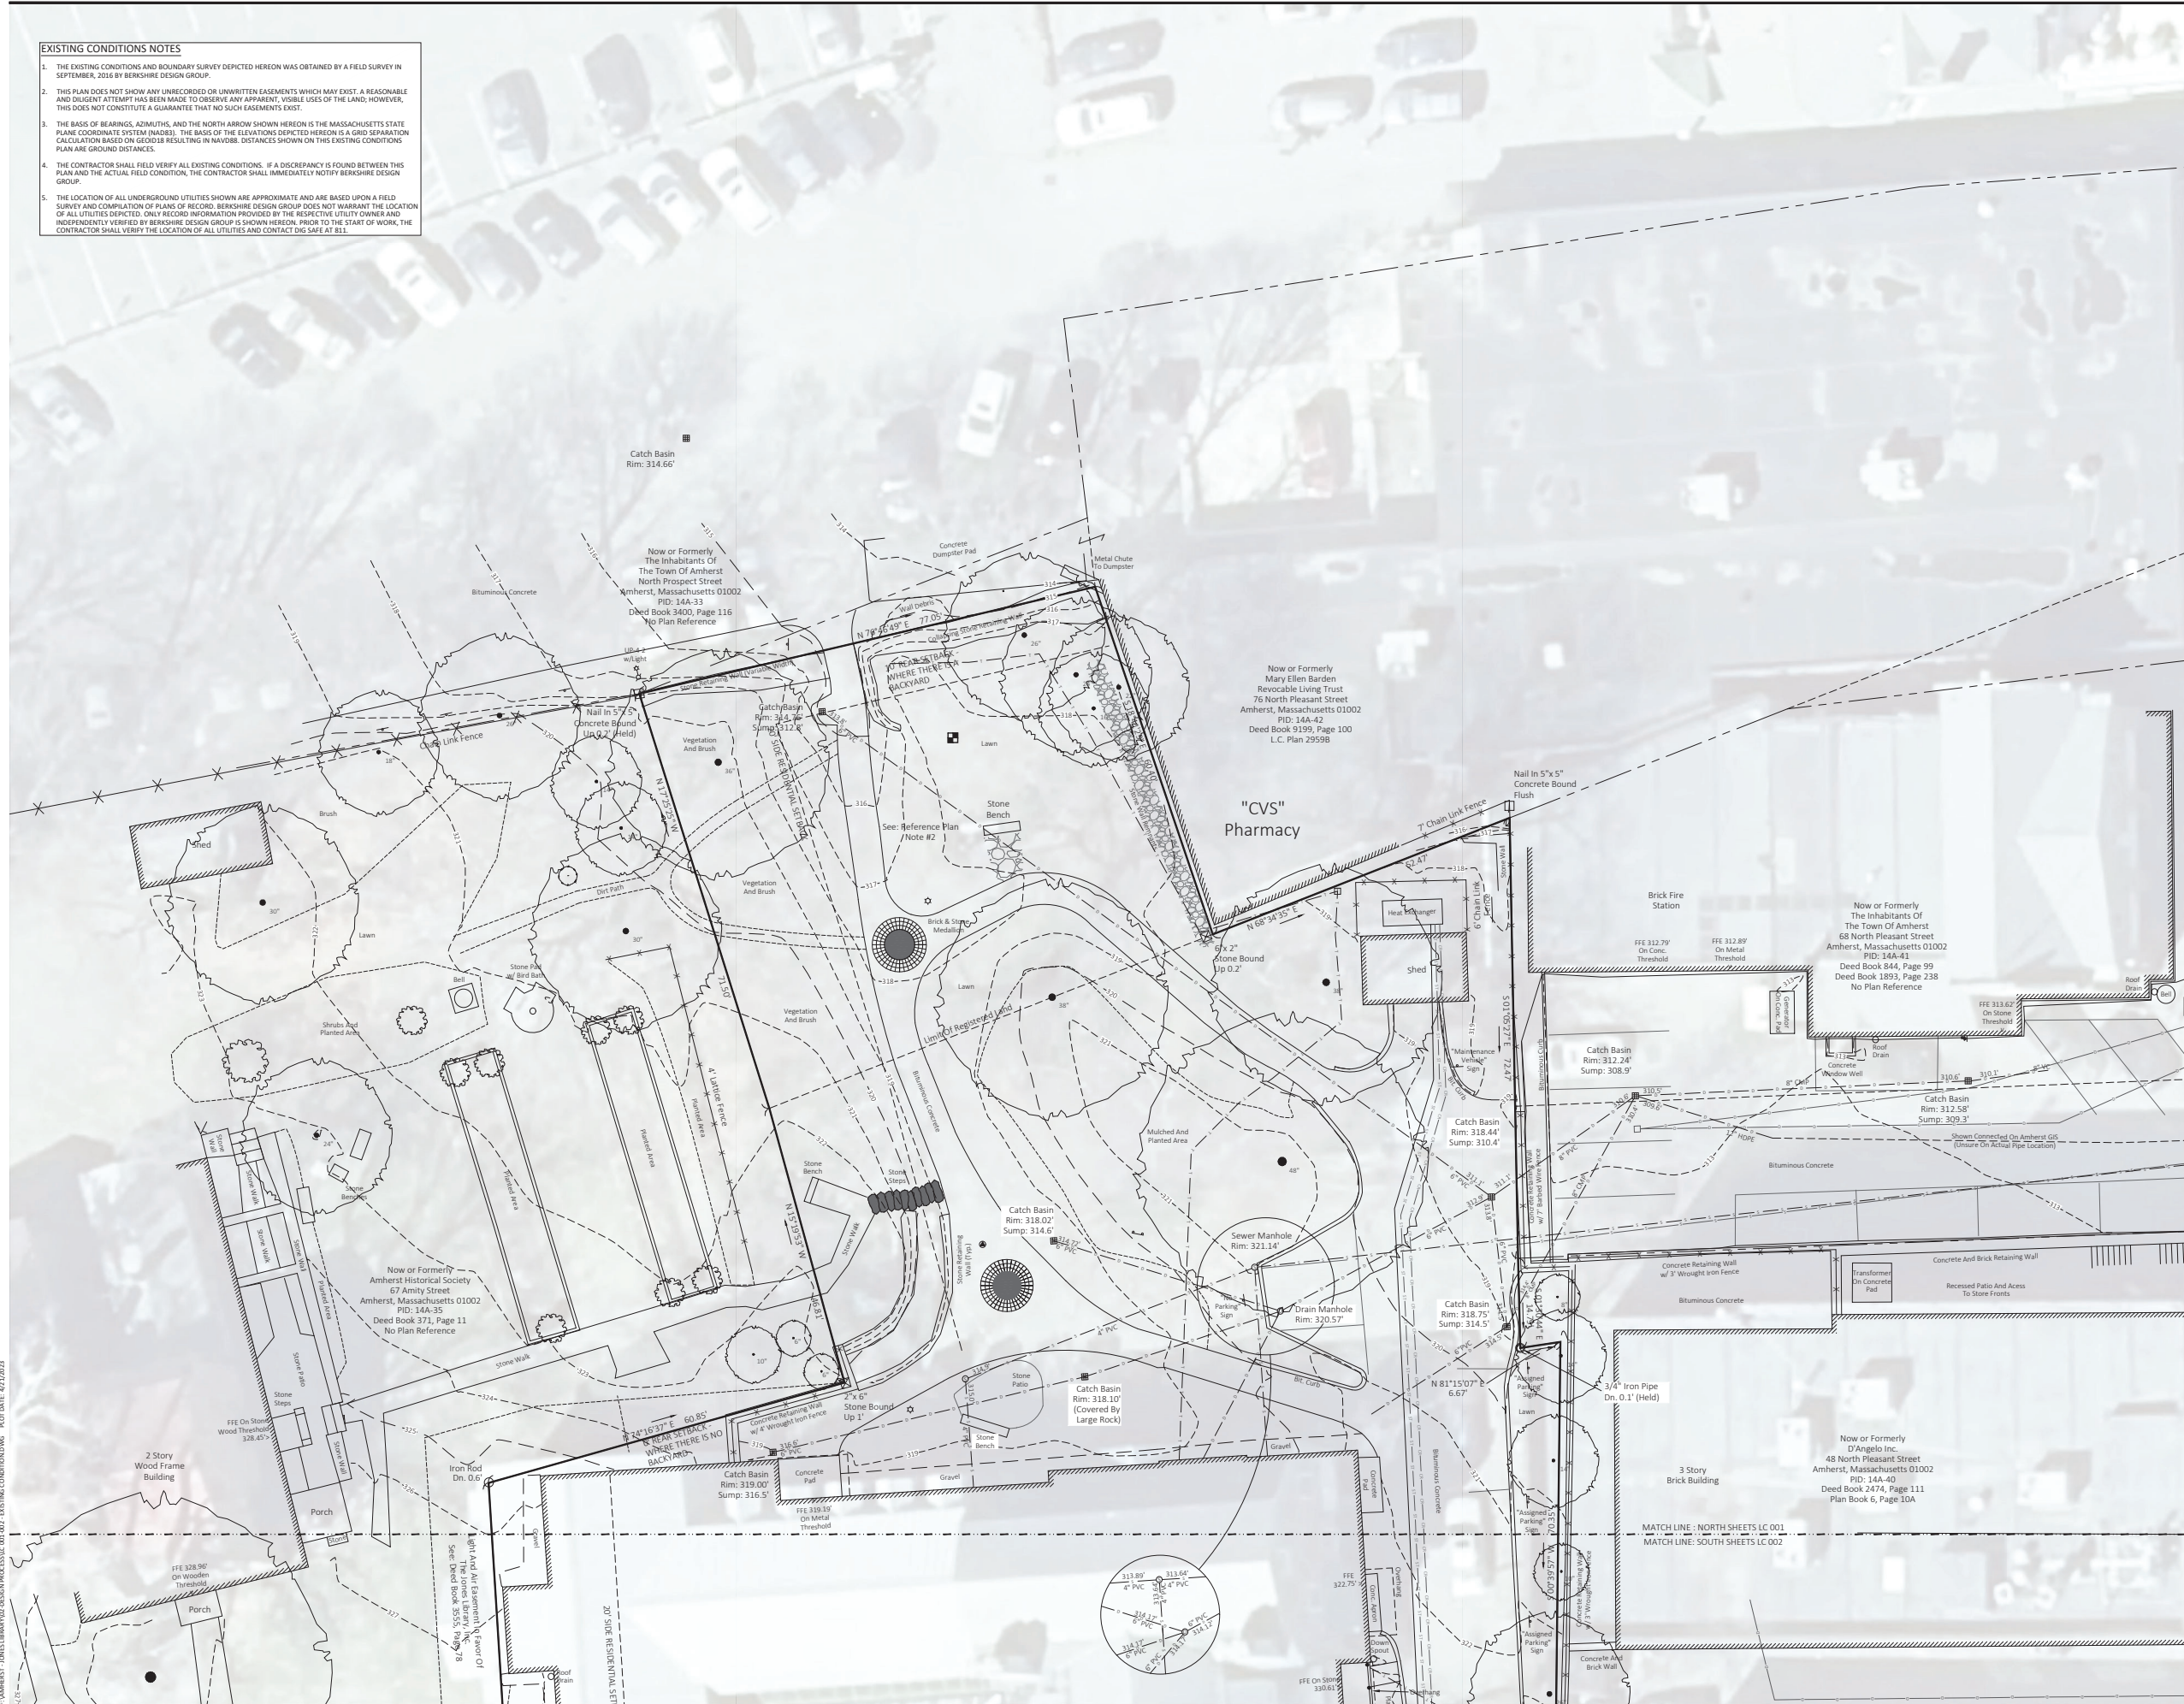
5. THE LOCATION OF ALL UNDERGROUND UTILITIES SHOWN ARE APPROXIMATE AND ARE BASED UPON A FIELD SURVEY AND COMPILED FROM RECORDS. BERKSHIRE DESIGN GROUP DOES NOT WARRANT THE LOCATION OF ALL UTILITIES DEPICTED. ONLY RECORD INFORMATION PROVIDED BY THE RESPECTIVE UTILITY OWNER AND INDEPENDENTLY VERIFIED BY BERKSHIRE DESIGN GROUP IS SHOWN HEREON. PRIOR TO THE START OF WORK, THE CONTRACTOR SHALL VERIFY THE LOCATION OF ALL UTILITIES AND CONTACT DIS SAFE AT 811.

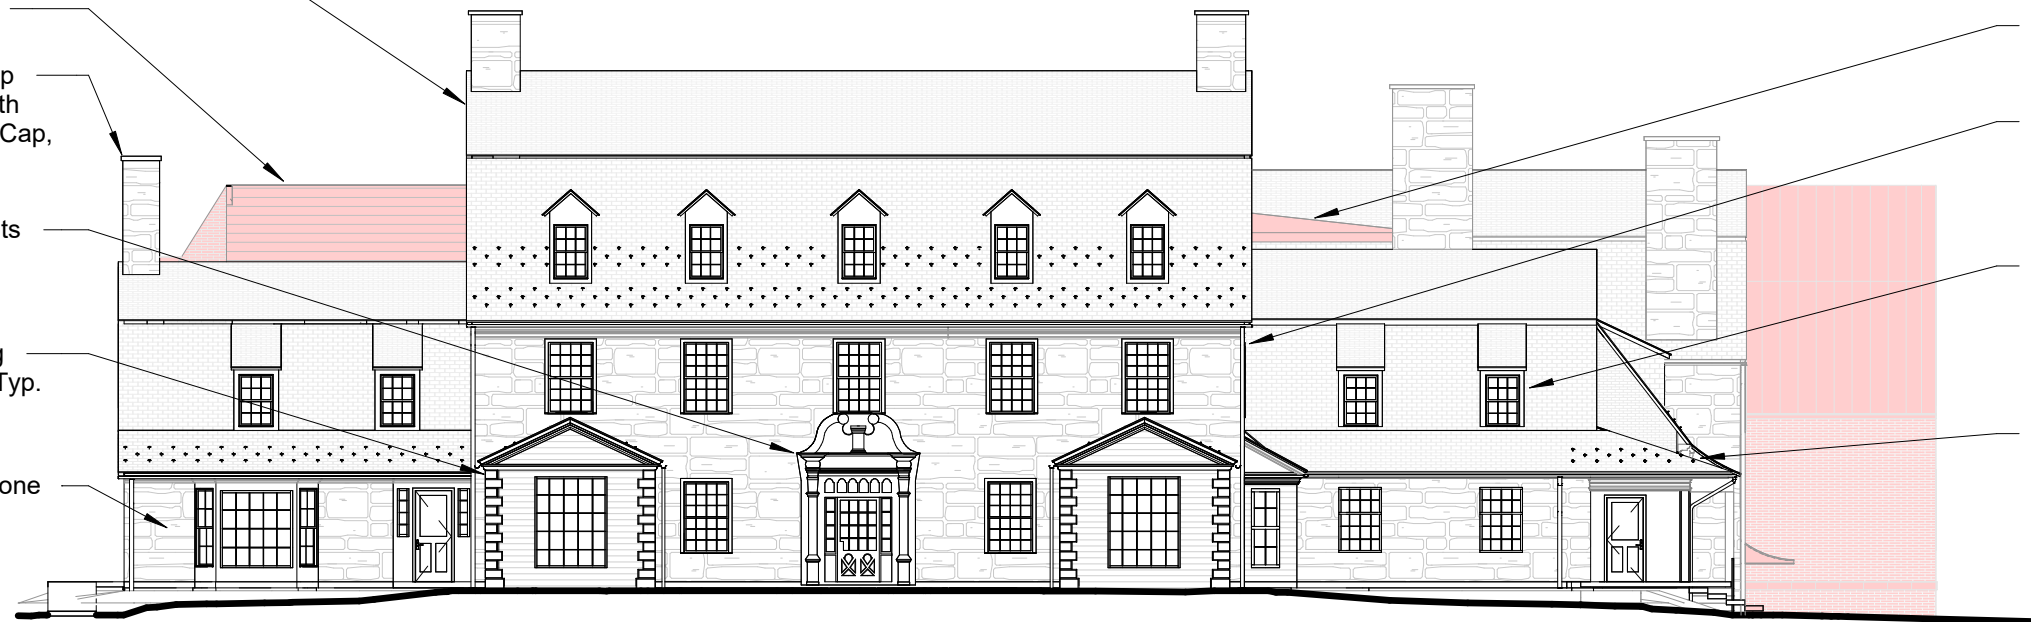
Copper Snow Gaards To Match Existing, Typ.

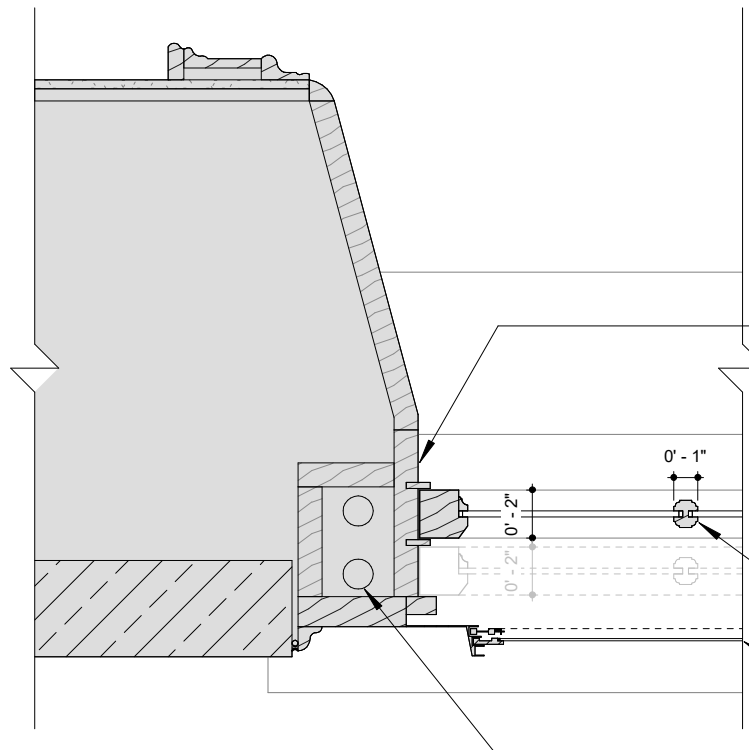
All Dimensions Shall Be Verified In Field And All New Construction Shall Match Existing Wood Species, Profile, And Finish
