6797/Jones Library, Amherst

October 24, 2023

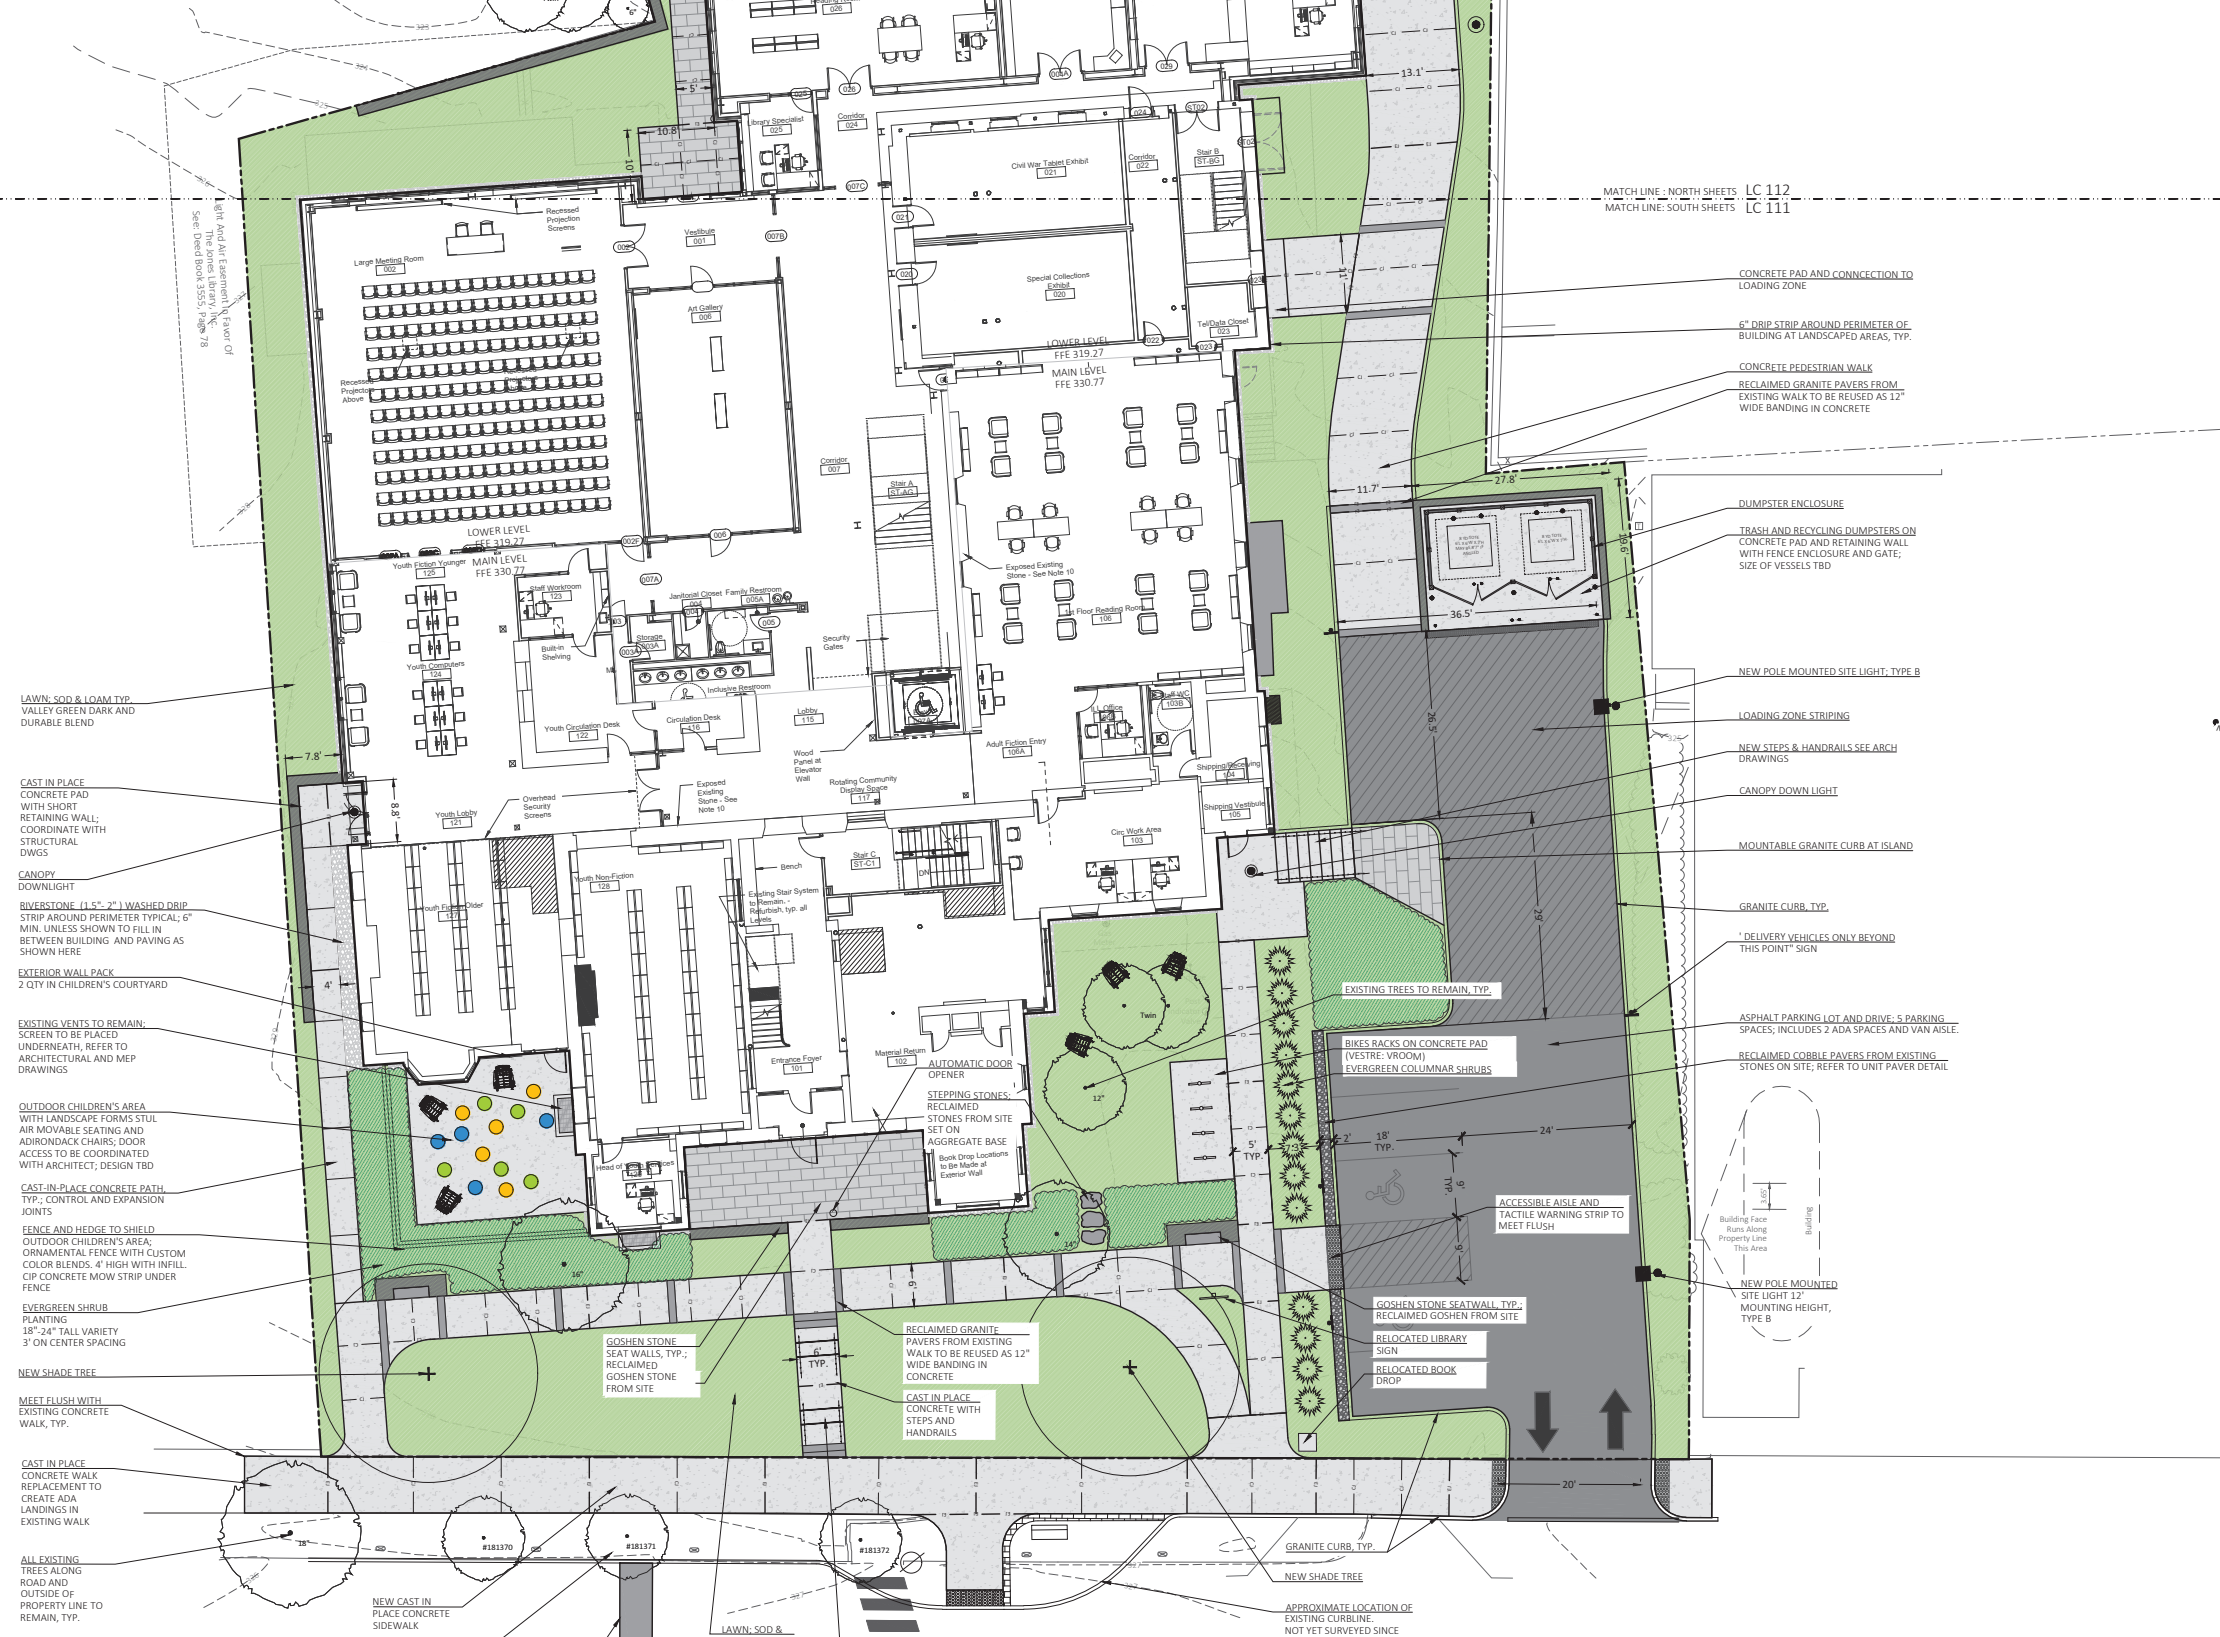
16. BERSHIRE DESIGN GROUP SHALL INSPECT SEEDING AREAS FOR ACCEPTANCE UPON NOTIFICATION FROM THE CONTRACTOR THAT AREAS ARE READY FOR REVIEW. THE WORK MAY BE ACCEPTED IN PARTS WHEN IT IS DEEMED IN THE BEST INTEREST OF THE OWNER.

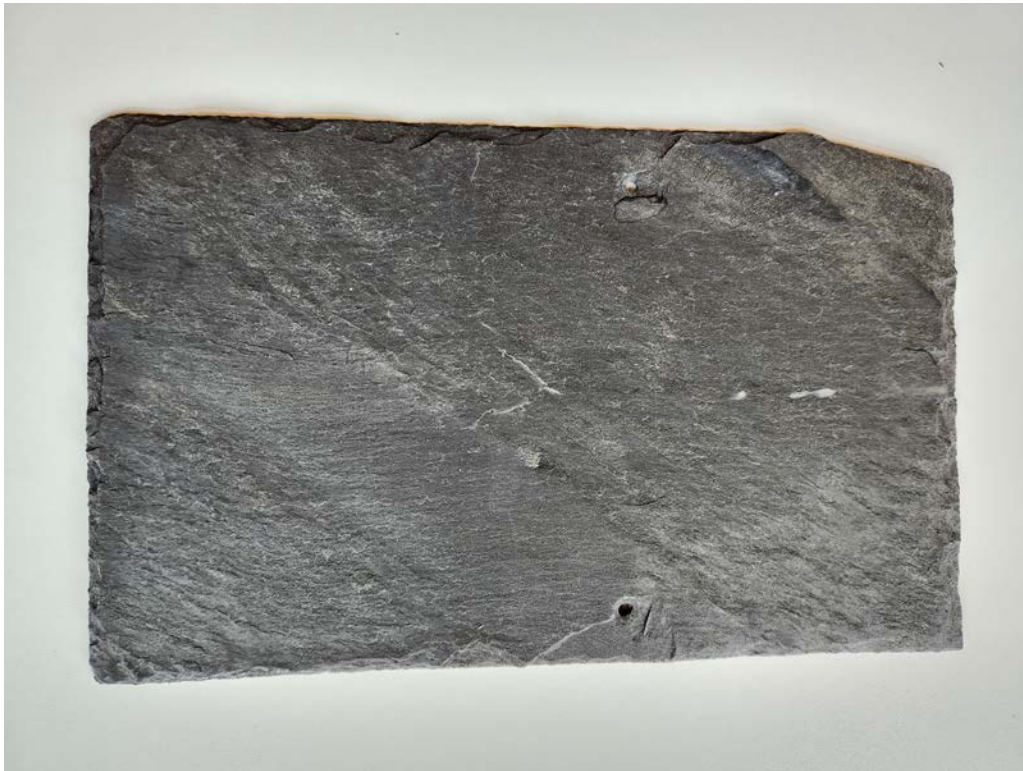
1. Salvaged historic Buckingham slate, typical condition

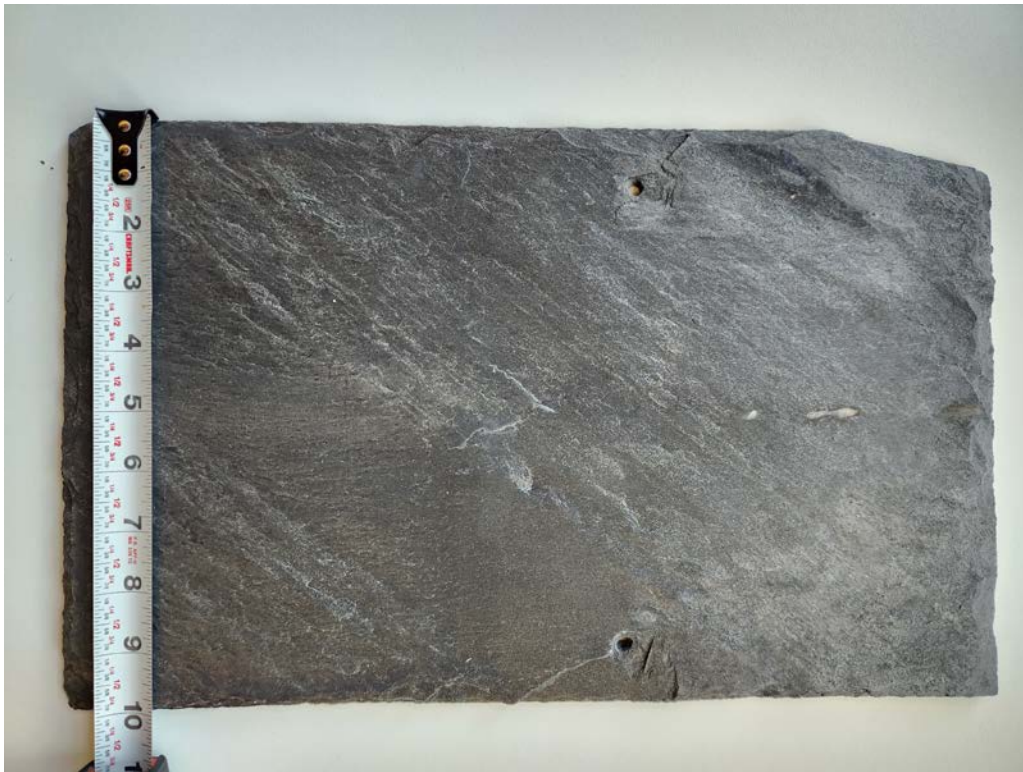
2. Salvaged historic Buckingham slate, typical condition

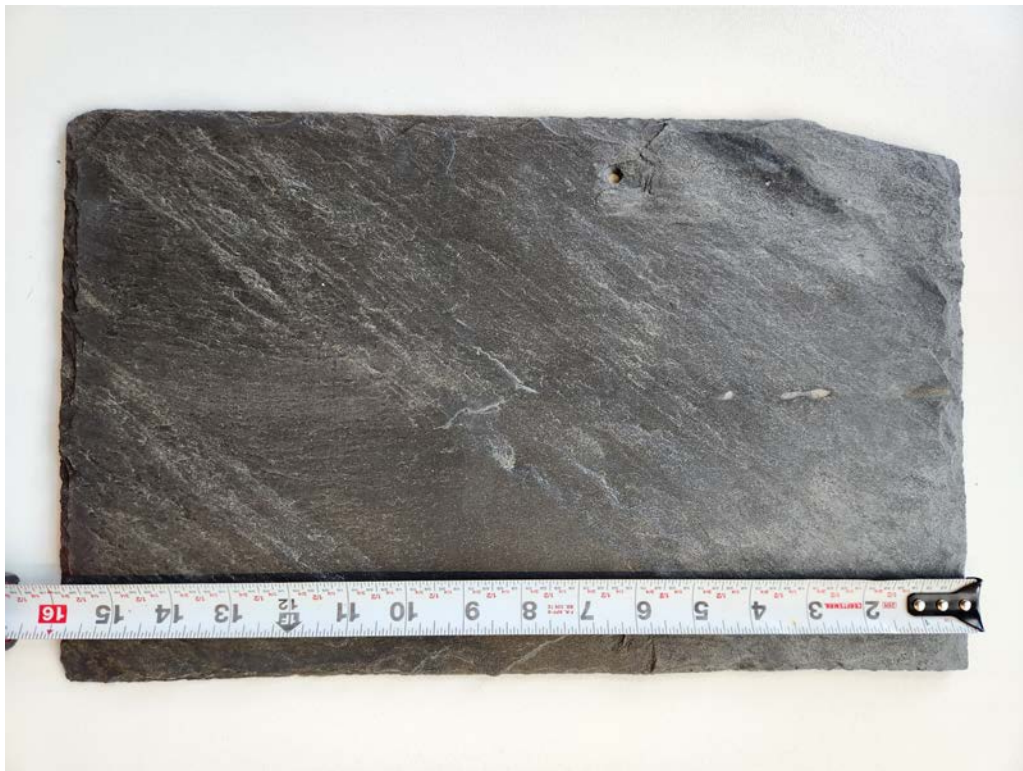
3. Salvaged historic Buckingham slate, typical condition

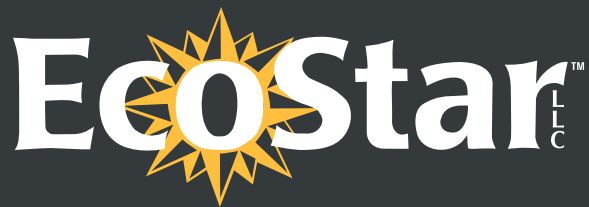
# Sustainable Roofing

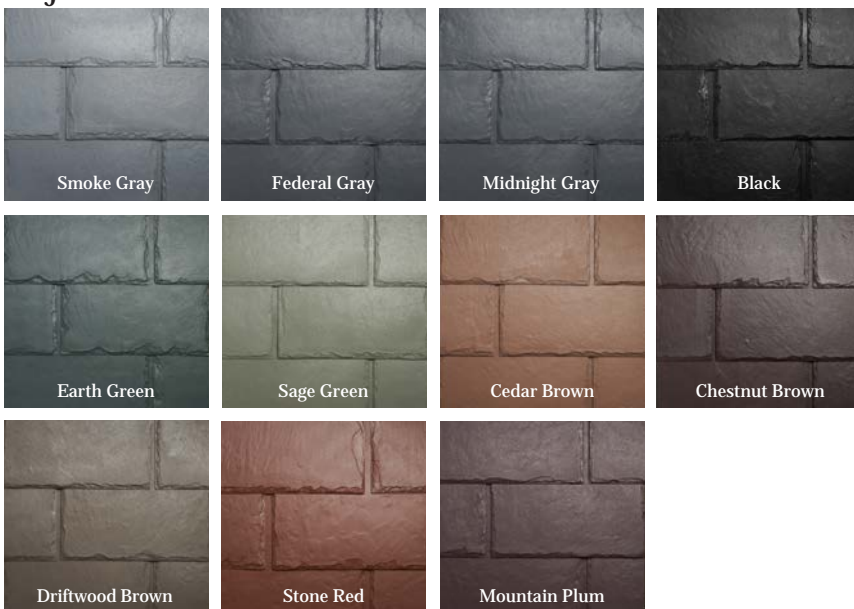
Note: Sample pieces, photographs or color samples may not accurately represent the true color level or variations of color blends that will appear on the roof. Before installation, ten tiles or so should be laid out and reviewed for conformity to desired color level. If color levels are unsatisfactory, advise your dealer before proceeding with installation. Colors and specifications subject to change without notice. EcoStar is not liable for color variations or shading. Tiles must be randomly blended for best results. Limited warranties carry terms and conditions. <sup>1</sup>Significant property insurance discounts may be available when upgrading or building a roof to protect against hail, wind or fire damage in regions where severe weather is common. EcoStar tiles meet or exceed industry standards for Impact Resistance and Fire Resistance. Contact your insurance provider for details.

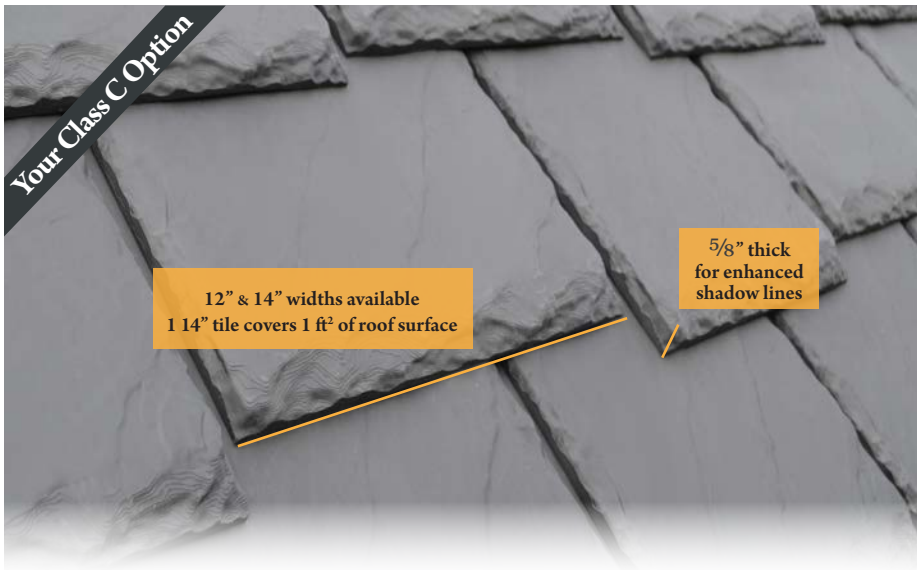
**B**igger is better when it comes to EcoStar LLC's latest innovation. Majestic Niagara Slate is a natural-looking,  $\frac{5}{8}$ " thick, synthetic slate roofing tile produced in 12" and/or 14" widths. This added size allows each Majestic Niagara Slate 14" tile to cover one square foot of roof deck at the 10" exposure (100 tile/square), maintaining a 2" headlap throughout. An additional 9" exposure option allows for the creation of unique looks using staggered, offset or random width installations.

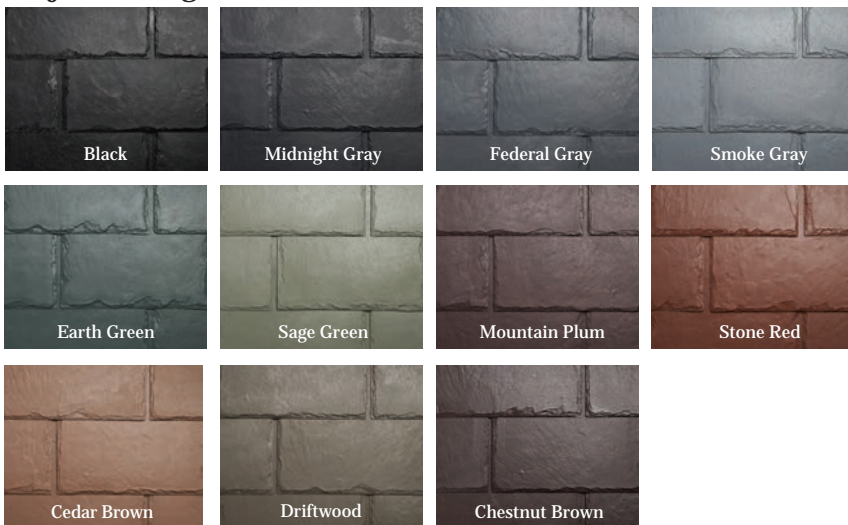
Note: Sample pieces, photographs or color samples may not accurately represent the true color level or variations of color blends that may appear on a roof. Before installation, ten tiles or so should be laid out and reviewed for conformity to desired color level. If color levels are unsatisfactory, advise your dealer before proceeding with installation. Colors and specifications subject to change without notice. EcoStar is not liable for color variations or shading. Tiles must be randomly blended for best results. Limited warranties carry terms and conditions. <sup>1</sup>Significant property insurance discounts may be available when upgrading or building a roof to protect against hail damage in regions where severe weather is common. EcoStar tiles meet or exceed industry standards for Impact Resistance. Contact your insurance provider for details.

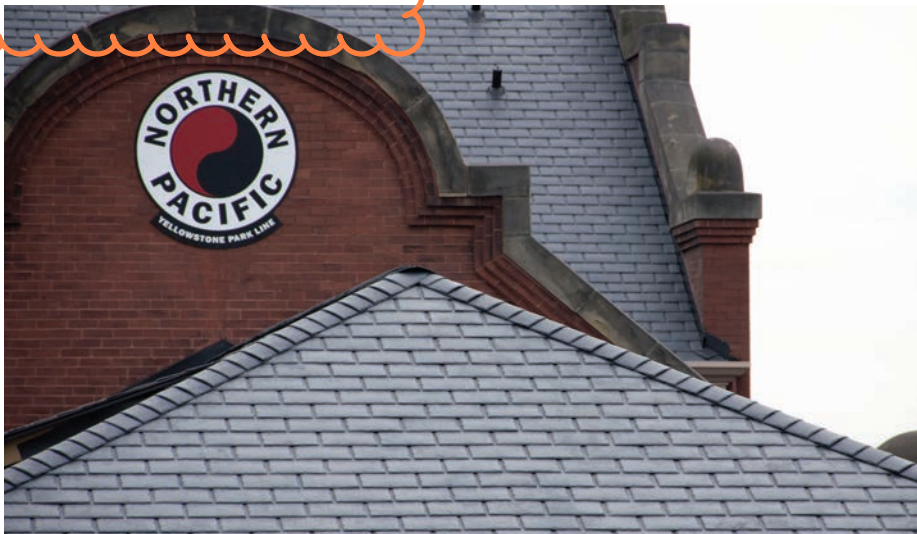
Embracing the continued progression of sustainable building practices and recognizing the numerous challenges which have impacted economic conditions, EcoStar LLC proudly offers Empire Slate in its collection of premium steep slope roofing products.

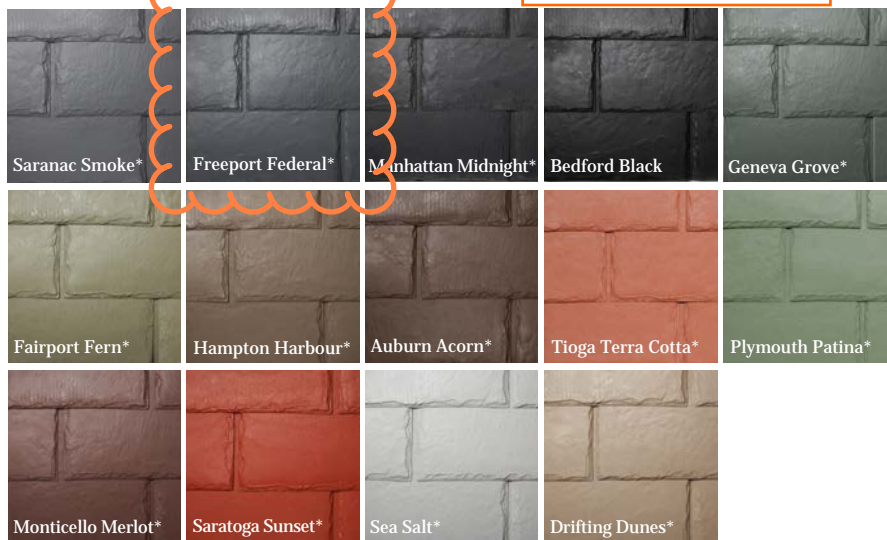
## Empire Slate Color Palette

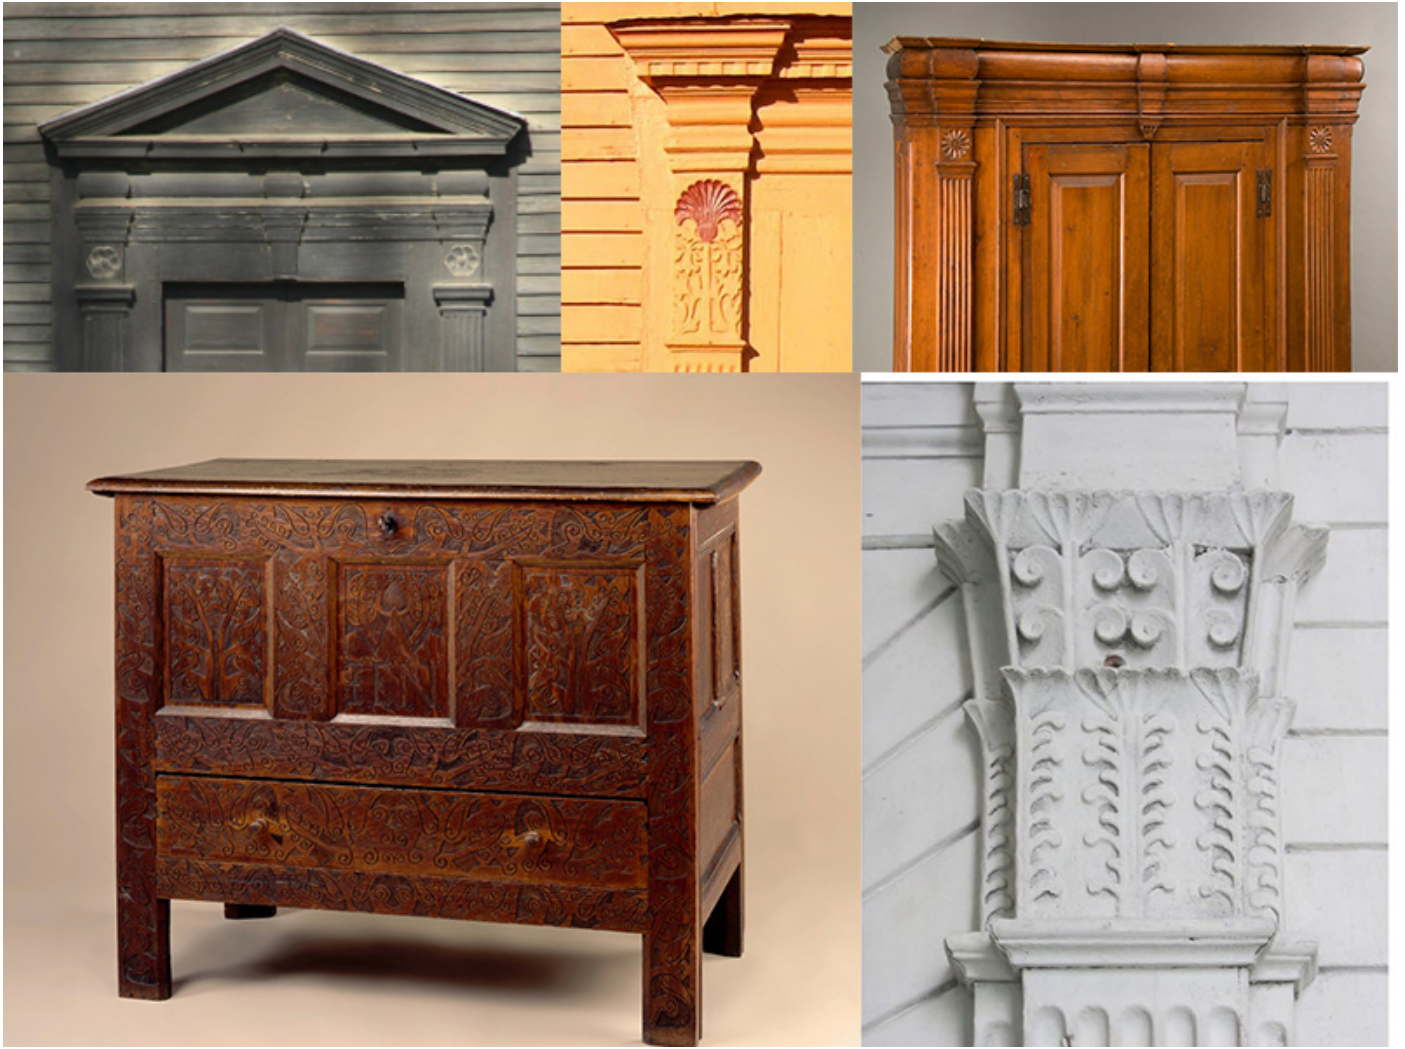
*Fig. 1 Seventeenth- and eighteenth-century Connecticut River Valley furniture and architecture is often decorated with ornamental details unique to the region. These take many forms; however, some more common examples include multi-petaled rosettes, pilaster caps carved with foliage, pulvinated friezes, and vine motifs.*

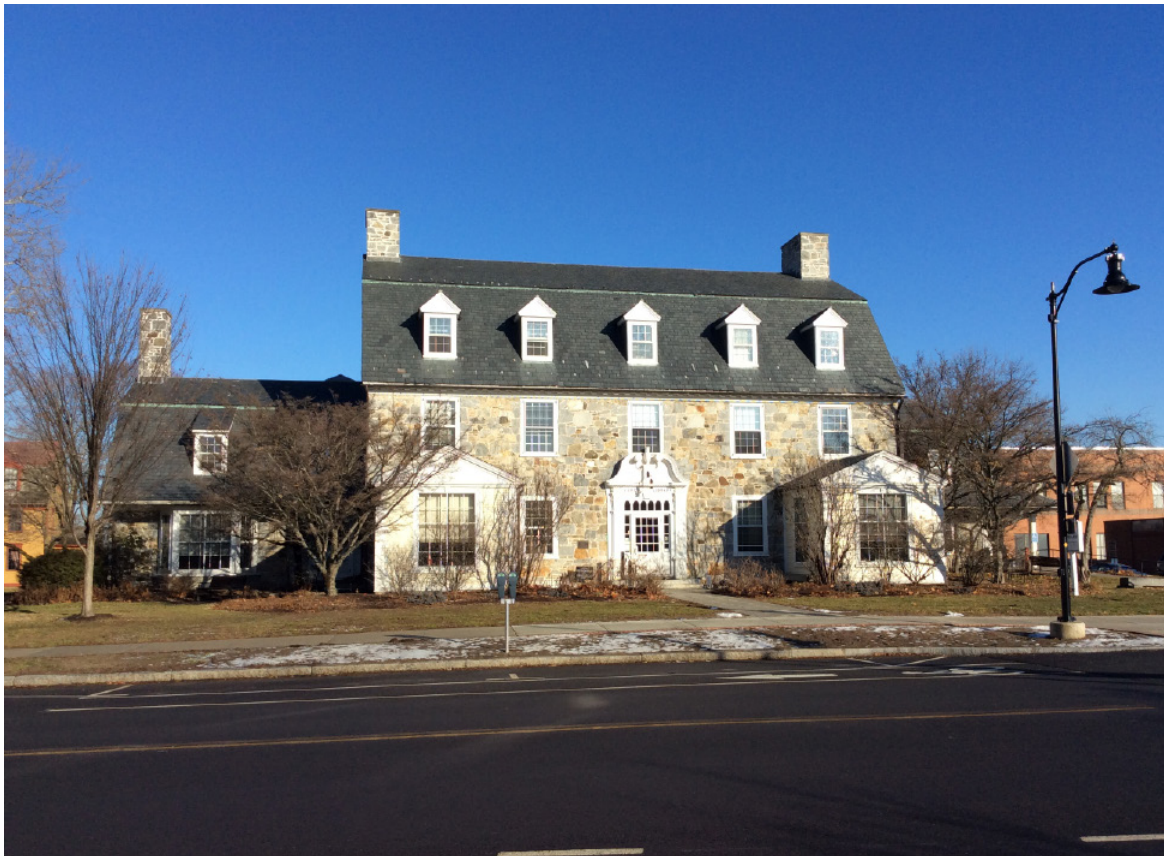
*Fig. 6 South elevation of the Jones Library, November 2017. Image courtesy of the Jones Library.*

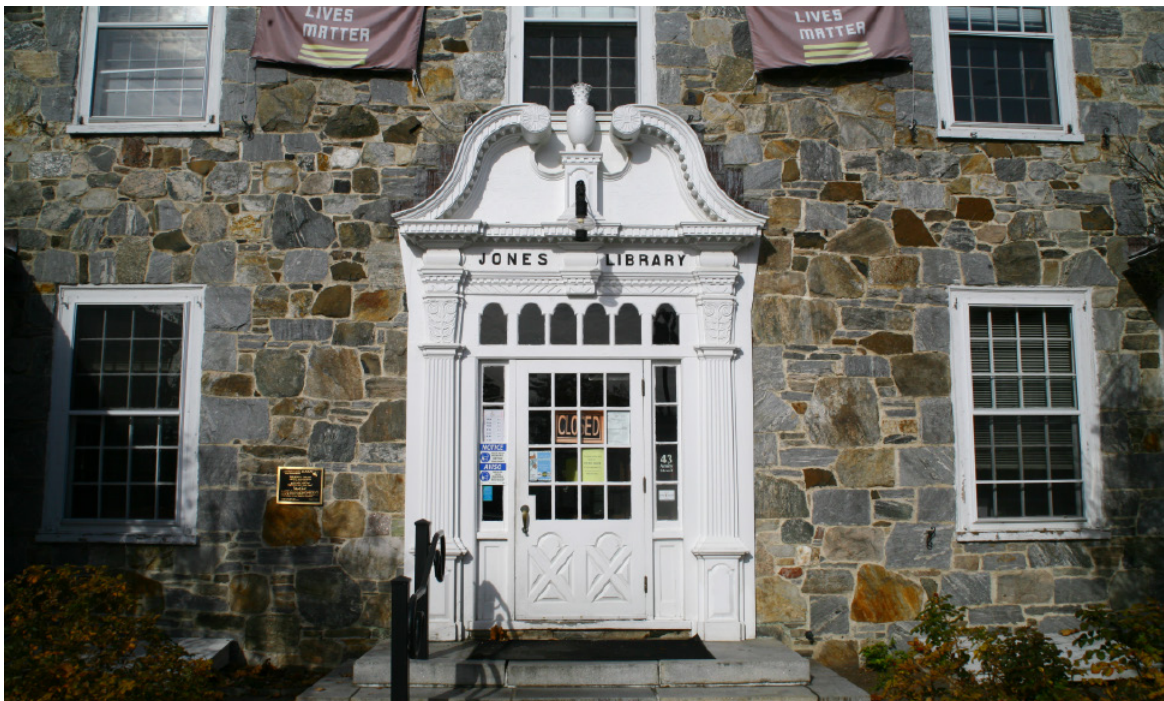
*Fig. 7. The frontis at the south entry is based on Connecticut River Valley door surrounds popular during the mid-eighteenth century. These door surrounds drew from classical examples illustrated in English architectural treatises and found in urban areas along the coast; however, they employed architectural details and proportions unique to the valley. This twentieth-century adaptation takes the design one step further, incorporating a single glazed door and sidelights into the design. Note the carvings in the capitals and pineapple feature in the center of the scroll pediment.*

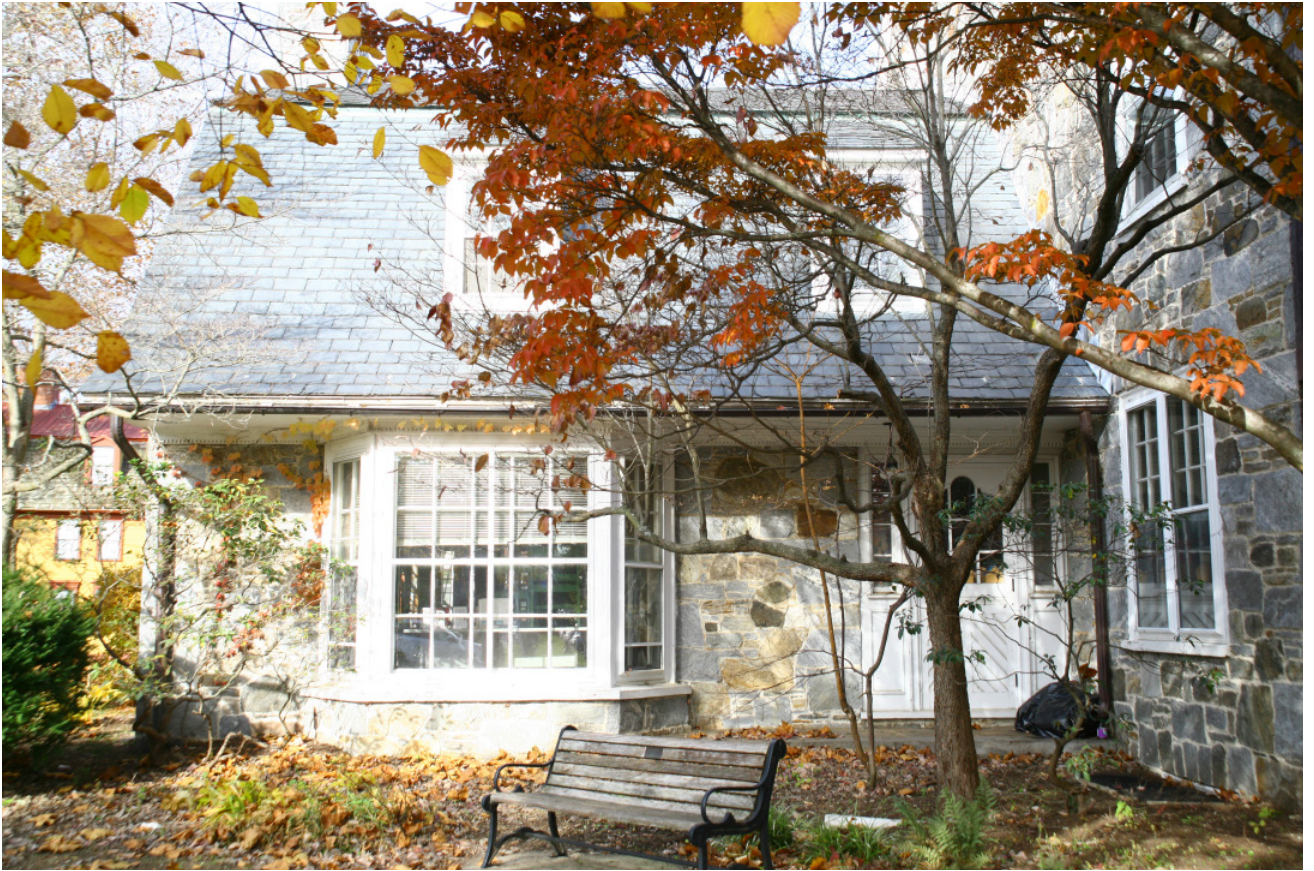
*Fig. 8 West wing. The door here originally provided access directly into the children's stacks and reading room. This entry is no longer used. The door here is very similar to the doors that were located at the east entry prior to being converted into a universally accessible entry.*

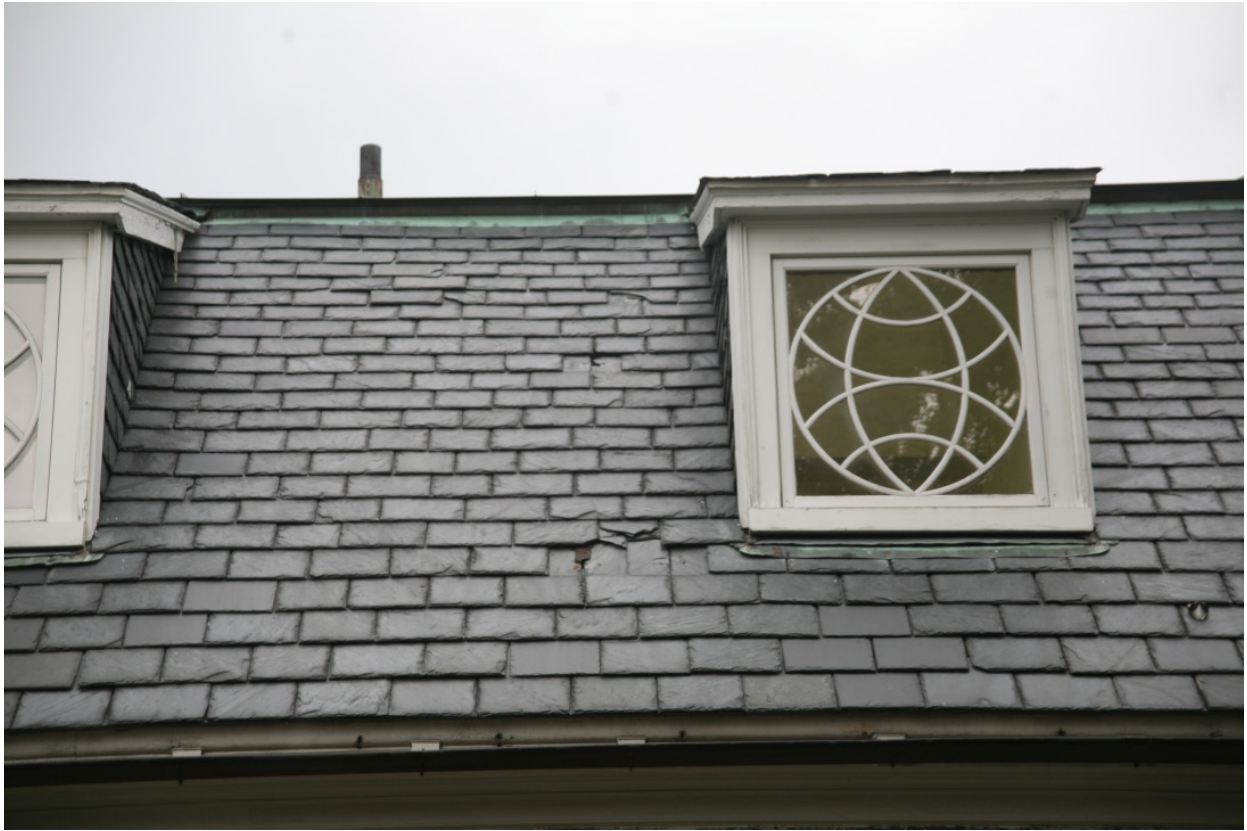
*Fig. 10 The dormers on the east side of the library are treated with decorative tracery that helps to break up the glazing in the opening. This window design shows up in the Kirstein Business Branch of the Boston Public Library designed by Putnam and Cox in 1930. Note the missing slates and condition of the roof in general.*

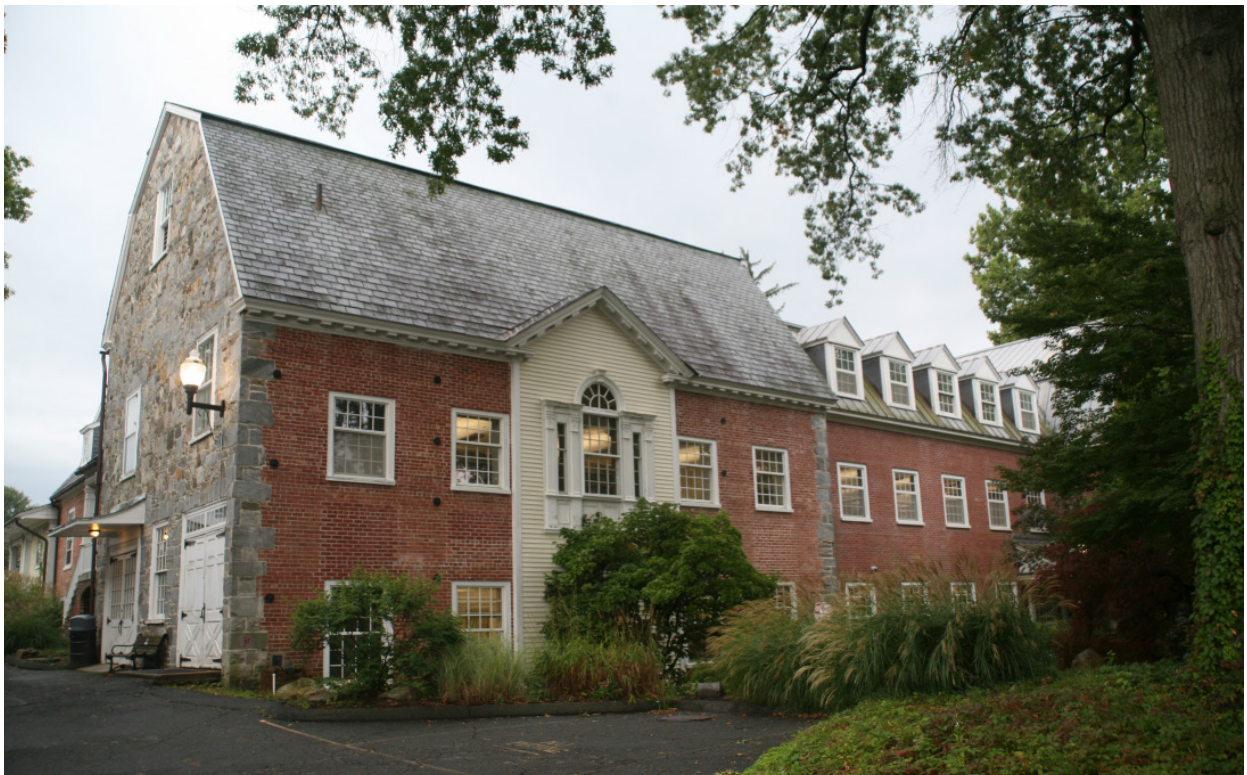
*Fig. 11 North elevation of the east wing. The five-bay composition with center pavilion and Palladian window is a wonderful surprise on this lesser facade of the building. On the interior, the Palladian window formed a backdrop to the auditorium's stage, located at this end of the building.*

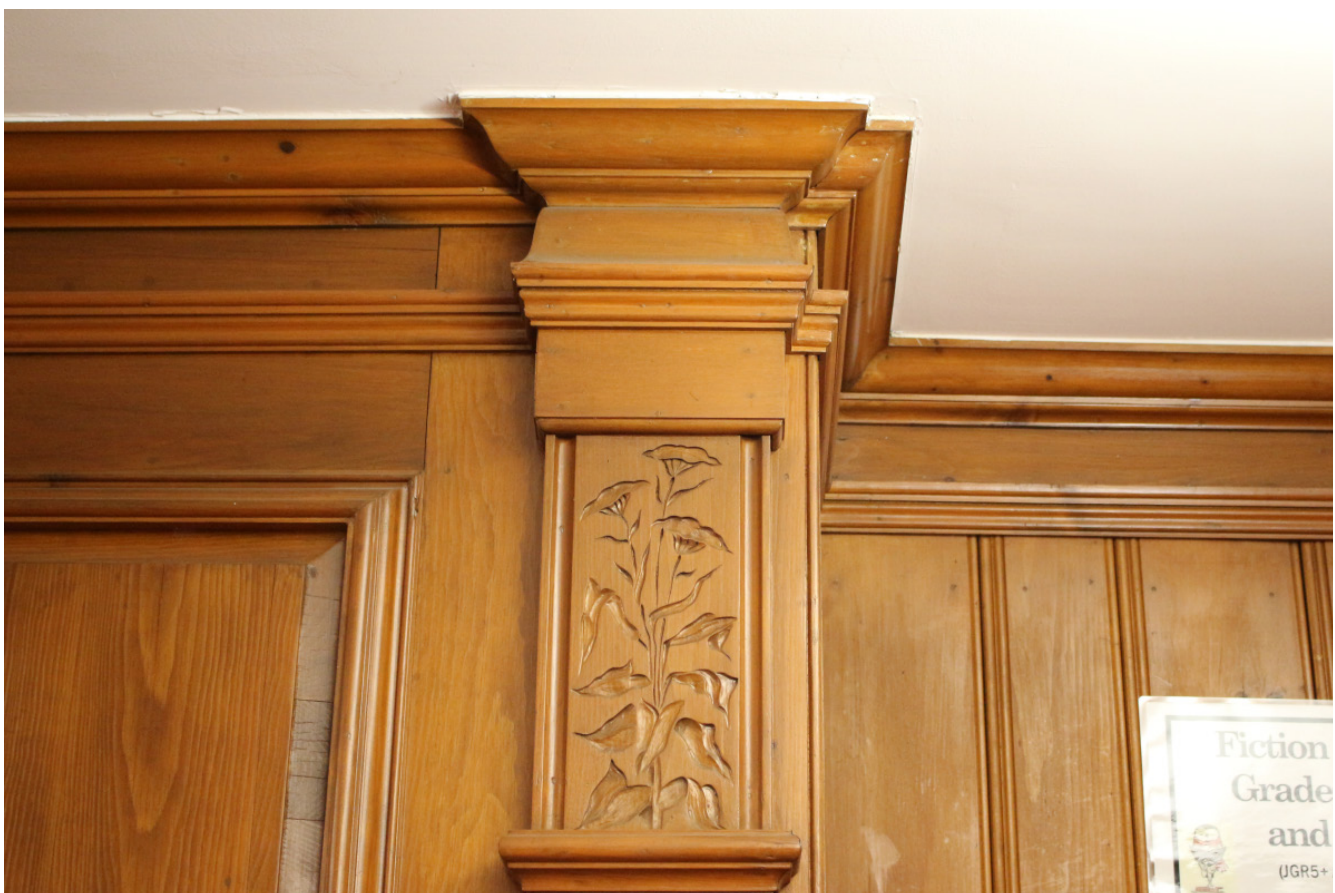
*Fig. 24 Floral motif found on the pilaster capitals of the chimney breast in the children's stacks. Note the extent of the molded surfaces throughout.*

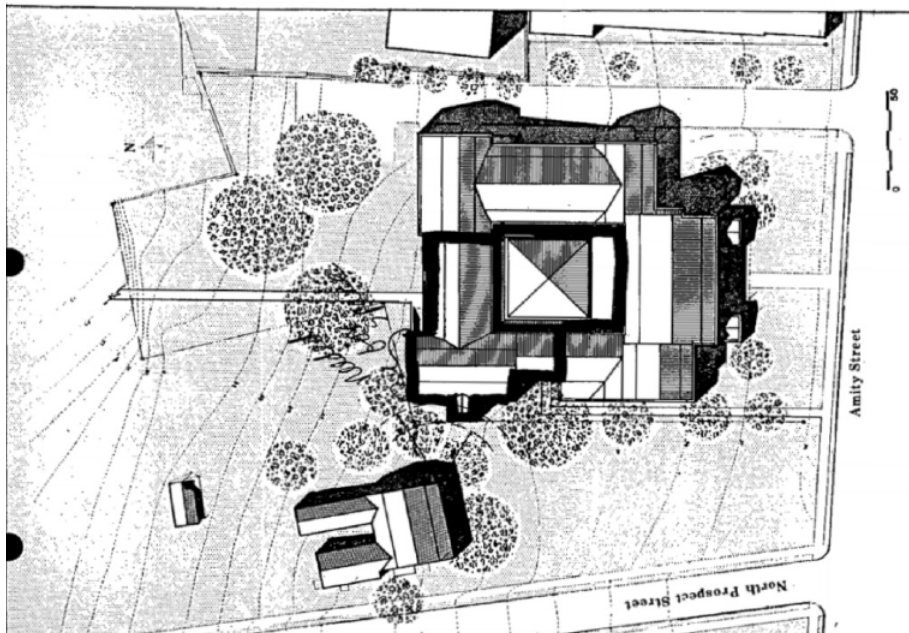
Fig. 28. The Mark Mitchell Associates addition completed in 1993 added to the north and west of the building and enclosed the court with a glass atrium, resulting in what is seen today.

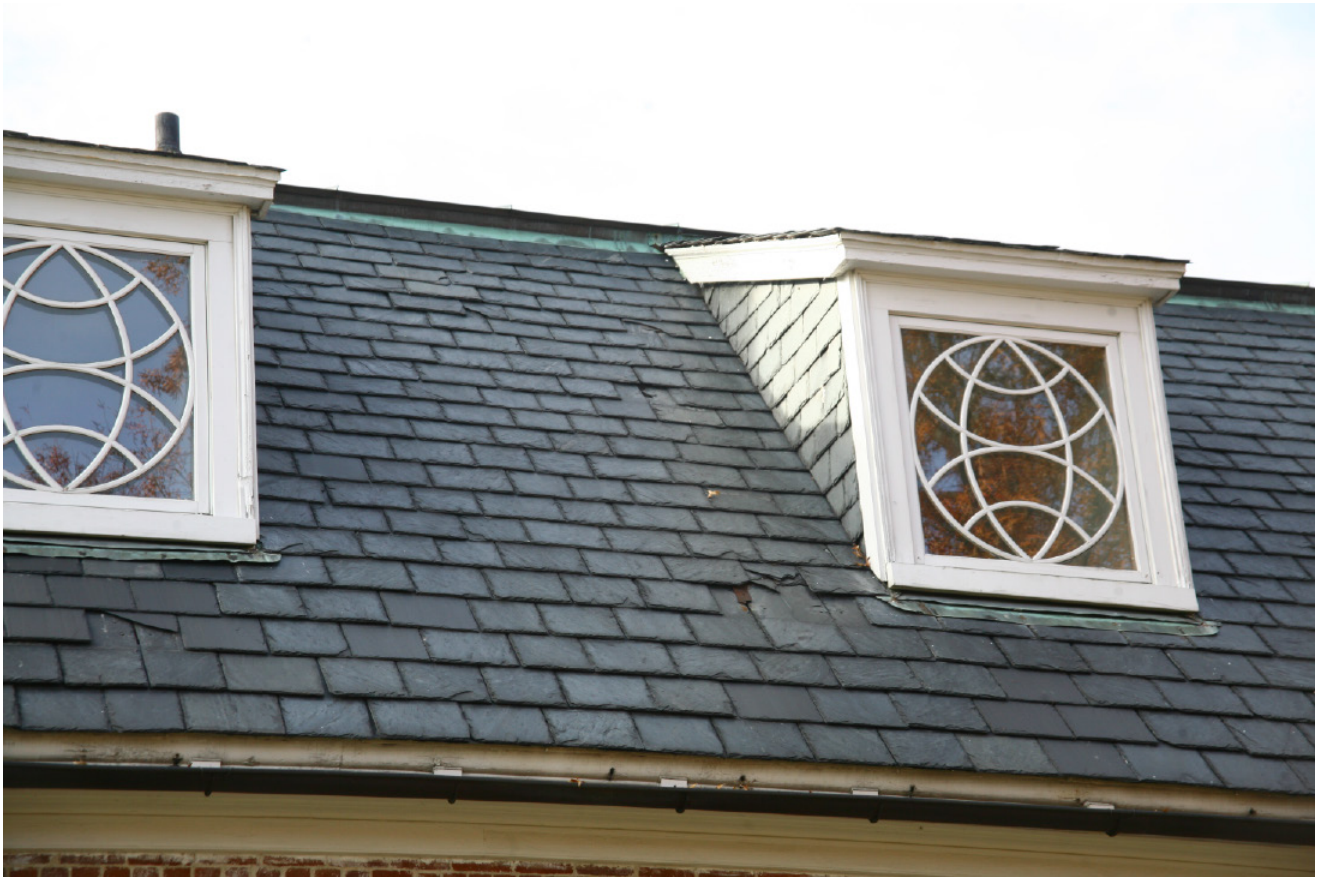
*Fig. 29 Detail of slate roof, east wing. Multiple missing and broken slates. The conditions here are representative of what is seen elsewhere across the roof.*

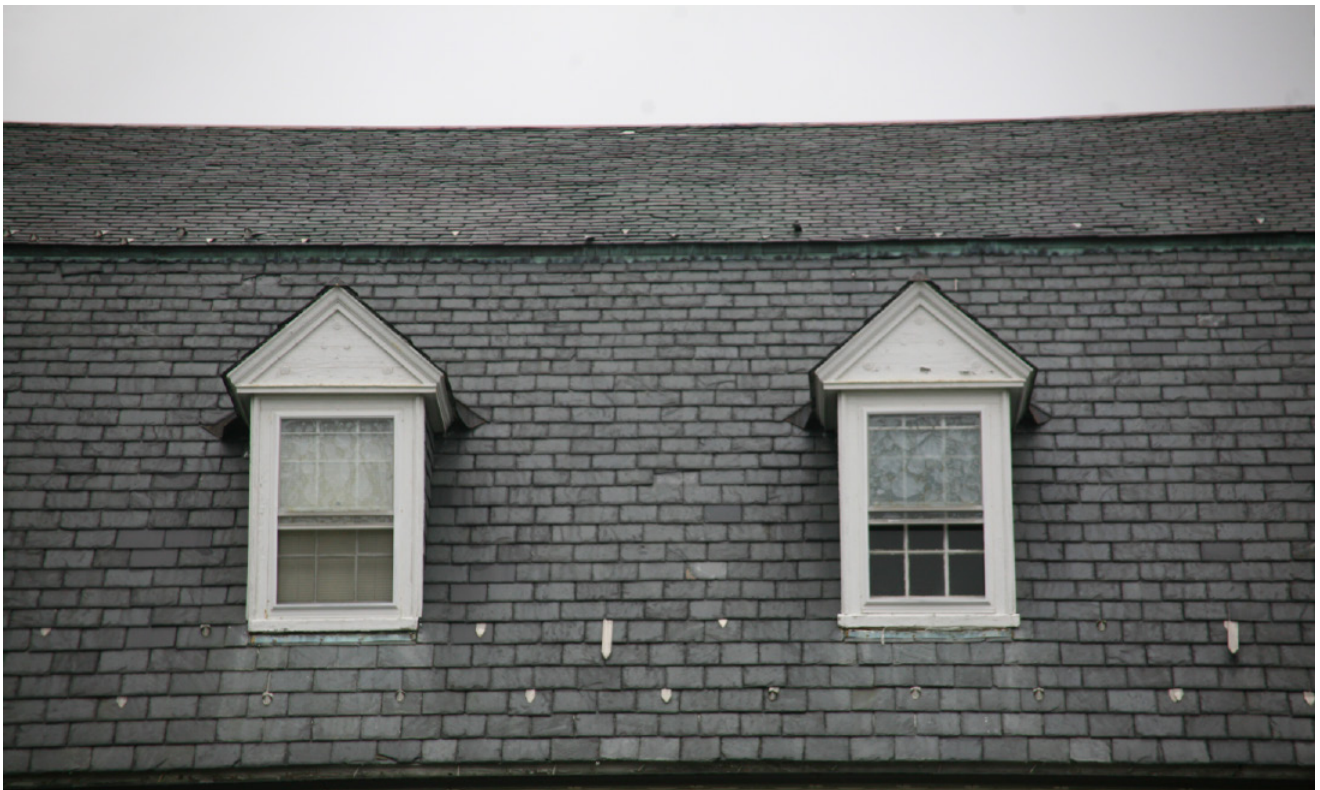
*Fig. 30 The slate roof was laid with a graduated exposure, so the lower slates show more of their surface to the weather than those nearer the curb (where the pitch of the roof changes). Notice the snow guards that have slipped and the random broken slates.*

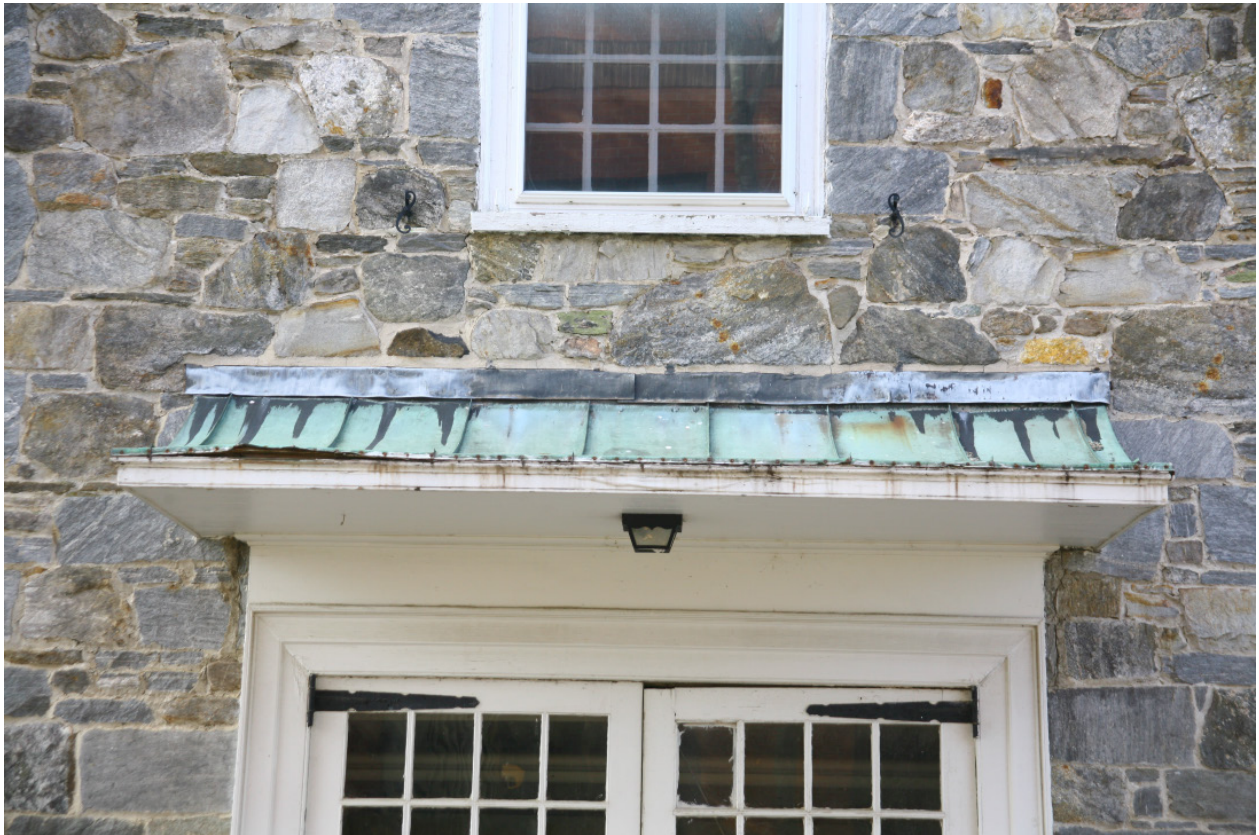
*Fig. 31 Copper roof at east barn doors. The roof is lifting away at the left end and is generally in poor condition. It has served its purpose and is at the end of its useful life. This roof should be replaced in-kind with new standing-seam copper roofing.*

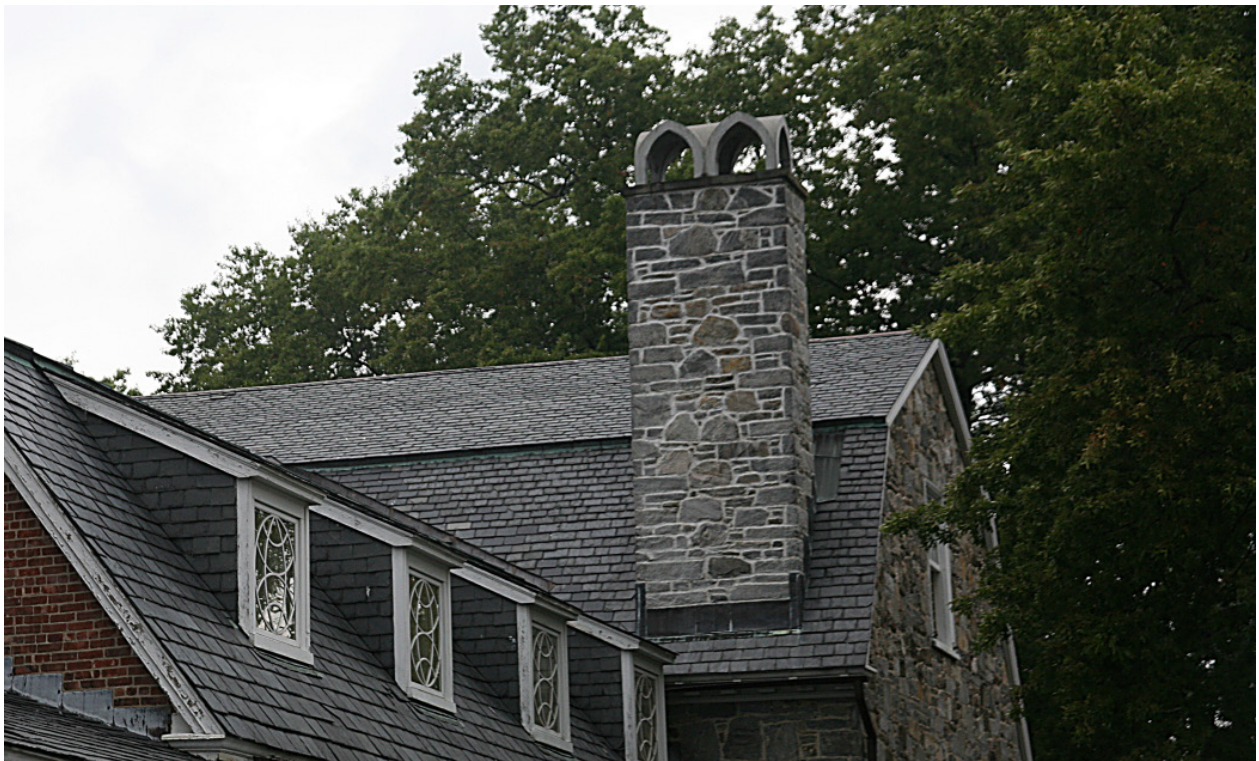
*Fig. 32 The modern mortar used to repoint the chimneys lacks the variety of color and texture found in the original mortar. Given its uniform gray appearance, even set high up on the building it stands out.*
