6797/Jones Library, Amherst

October 24, 2023

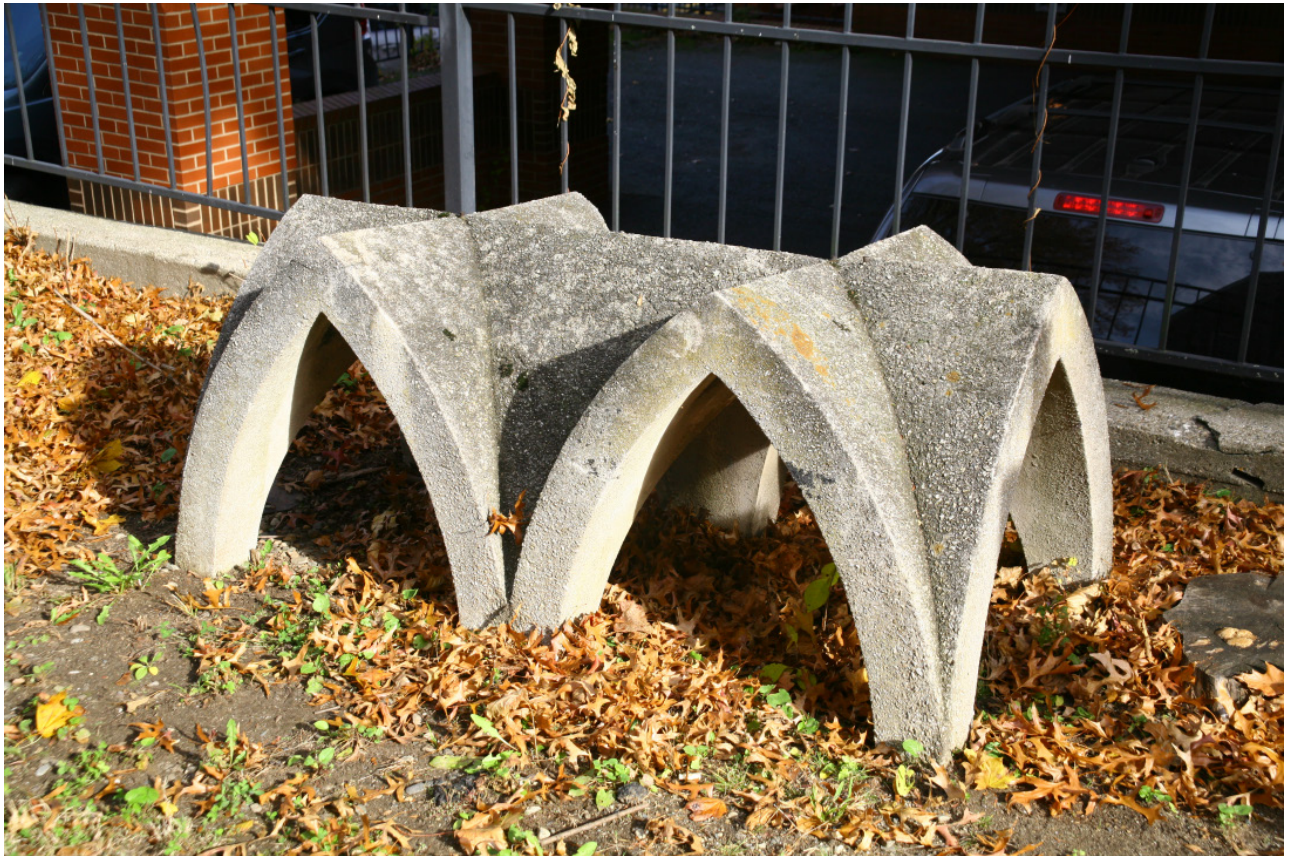
*Fig. 33 An example of one of the original chimney caps used on the building. This piece was saved when new caps were installed on the chimneys.*

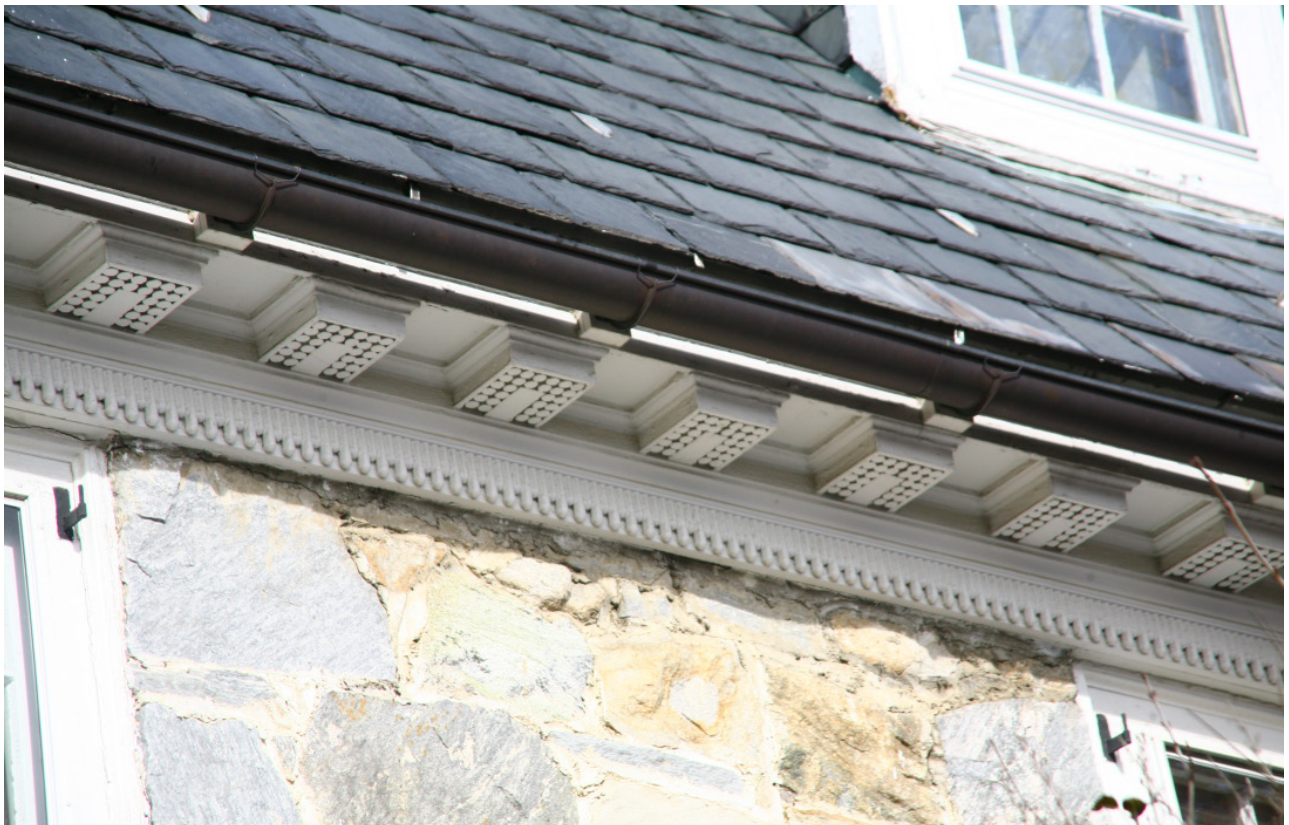
*Fig. 34 Detail of the decorative wood cornice found on the building. Note the half-round copper gutter in front of the cornice and shutter hardware at the window openings.*

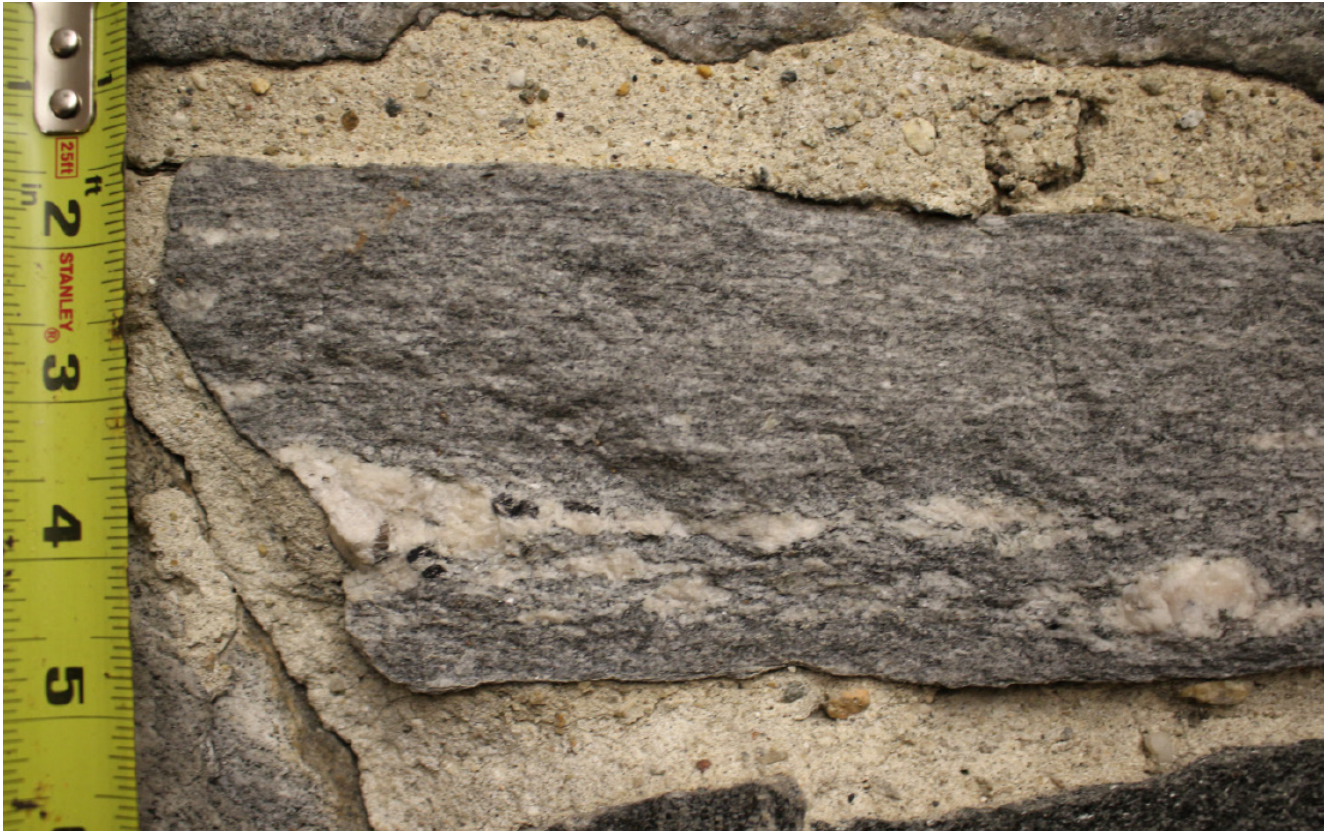
*Fig. 35 Detail of mortar in east wall of Special Collections. This closeup shows the color and texture of the original pointing mortar used in the building. This mortar is much different in appearance than that used to repoint the chimneys. Notice the variety of aggregate in the sand used. Any replacement mortar should be formulated to match the color of the original mortar and applied to match the profile and texture as well.*

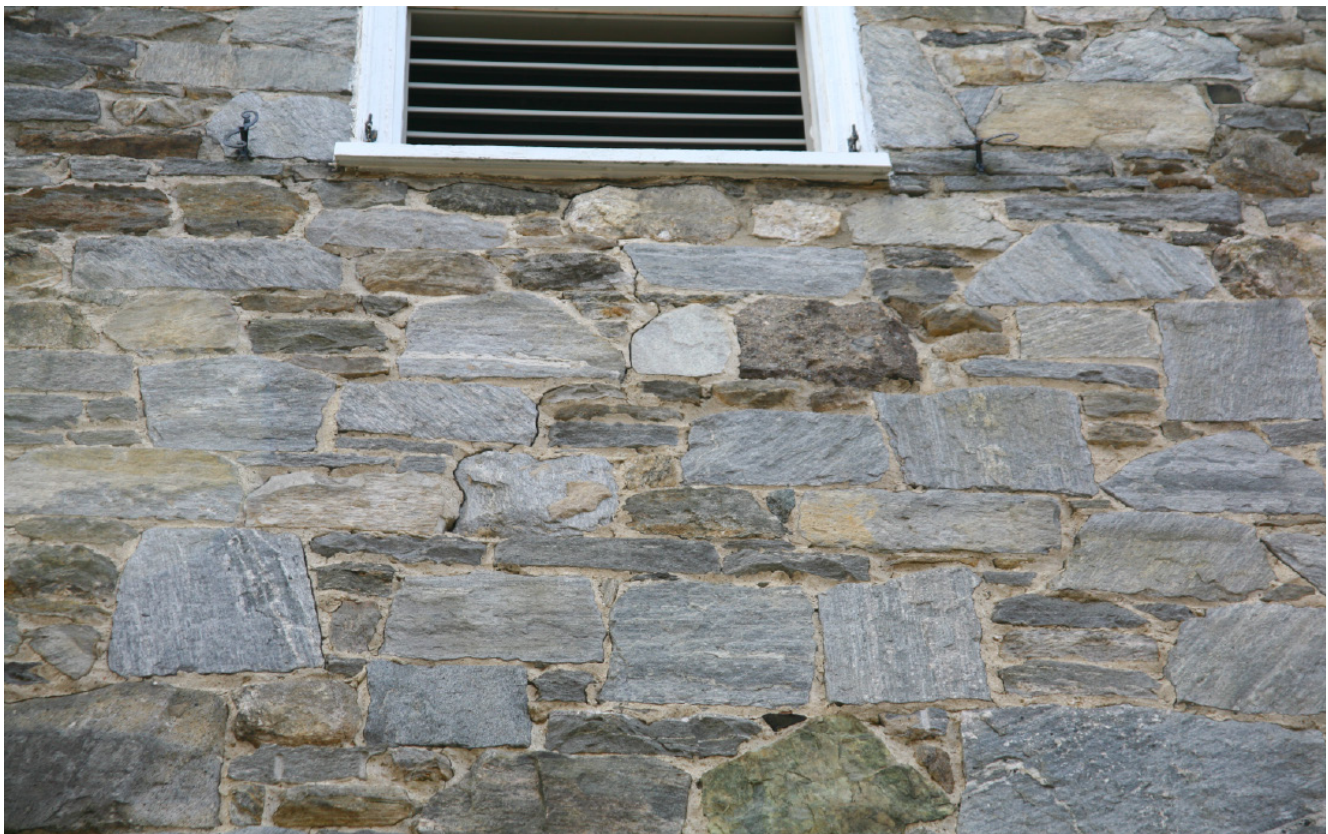
*Fig. 36. East elevation of the east wing at the north end. Note the vertical crack running up the center of the image.*

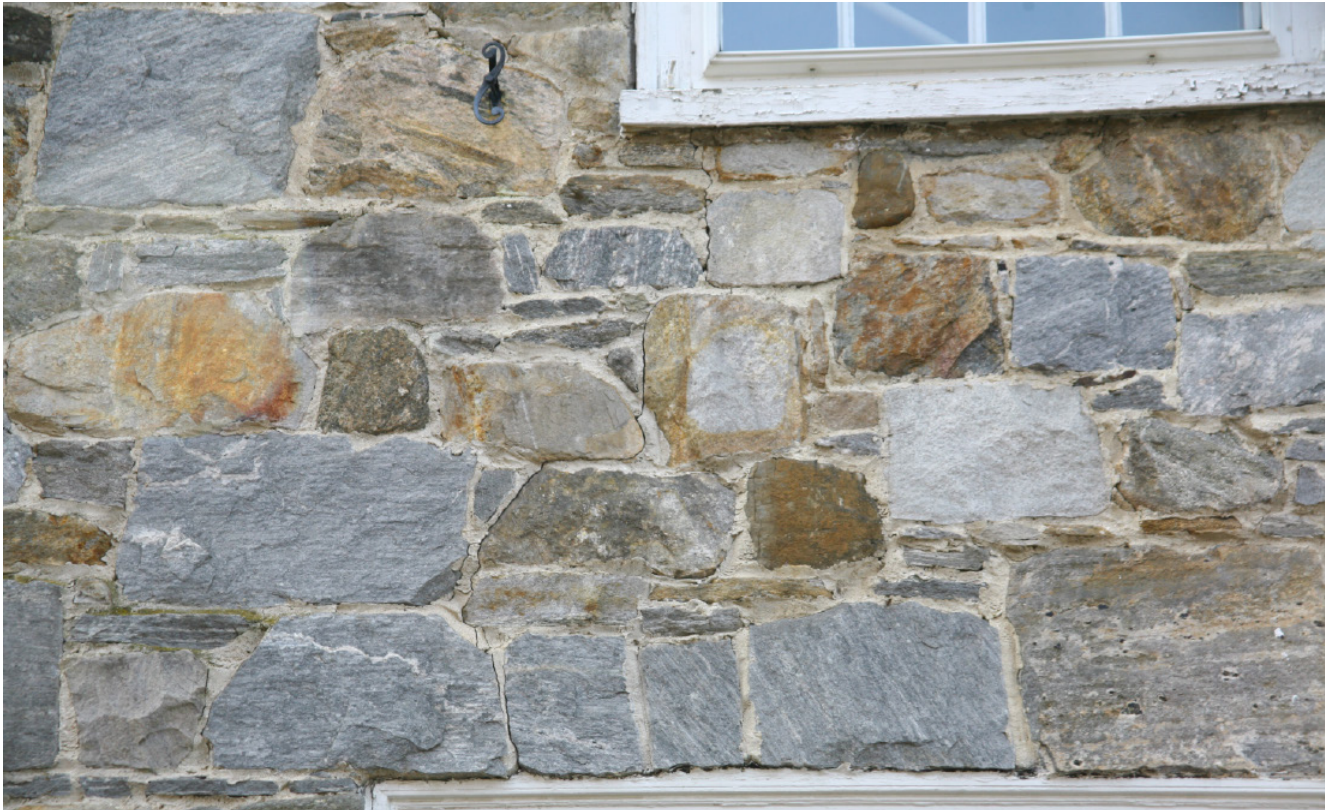
*Fig. 37. This is a continuation of the crack seen in fig. 36.*

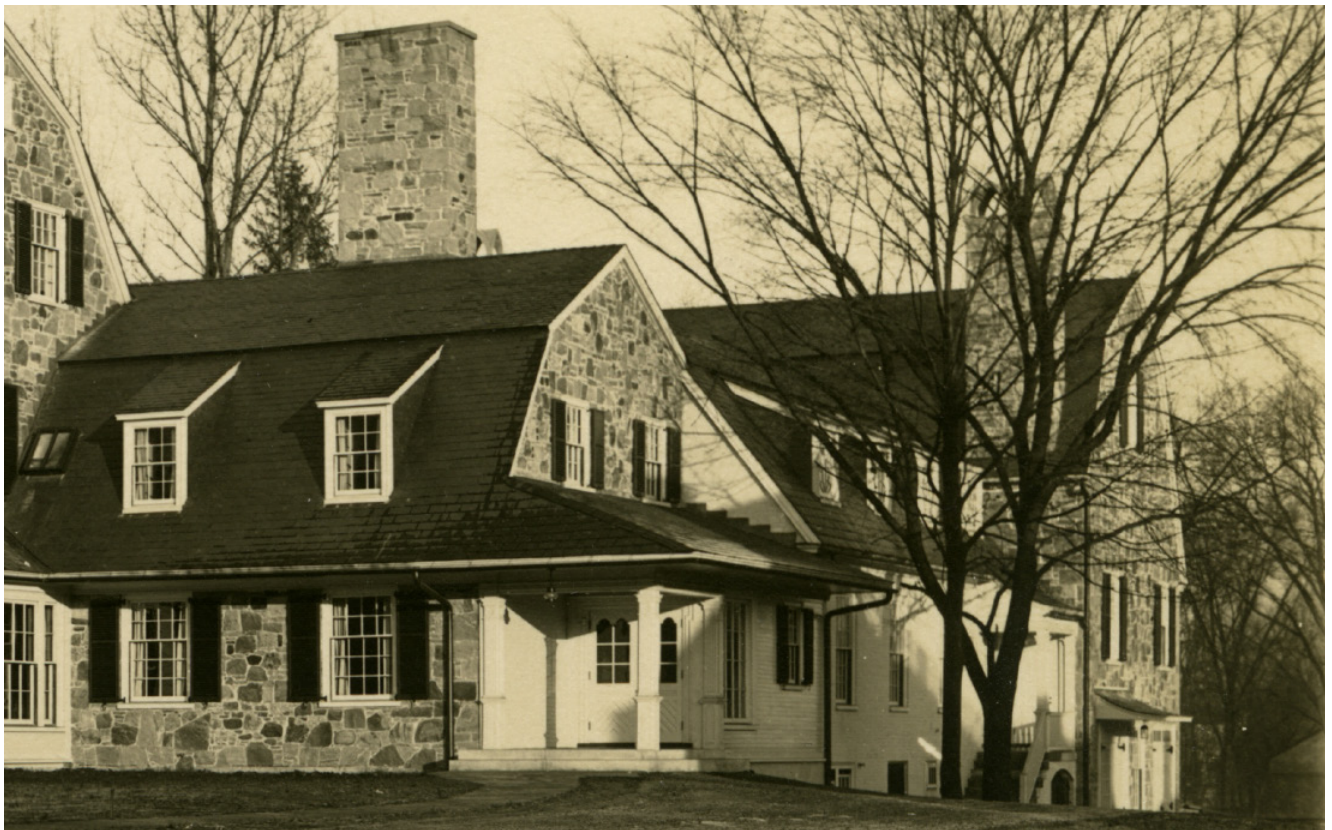
*Fig. 38 Detail of the east wing, circa 1928. Notice how the brickwork is painted. This would have presented a more finished appearance and tied the different portions of the wing together.*

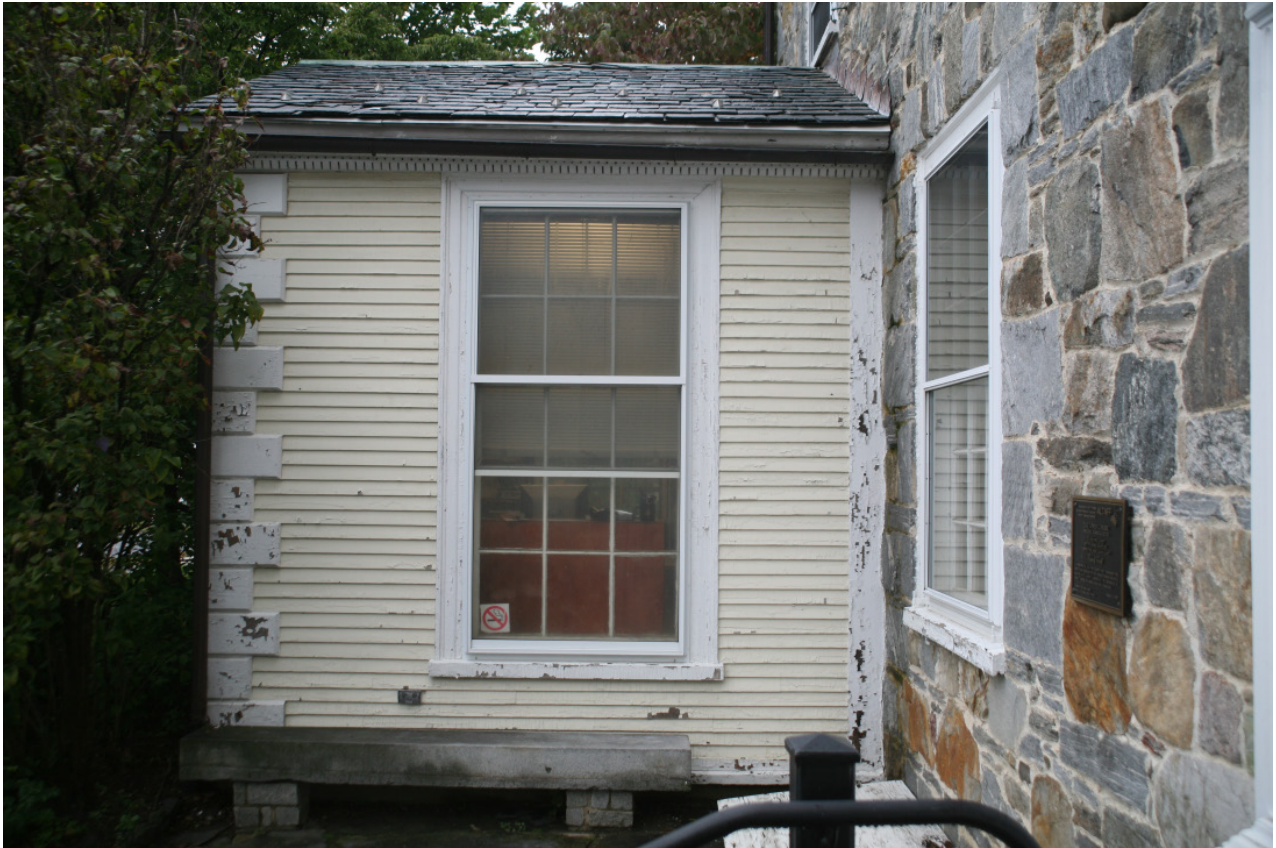
*Fig. 41 West sun porch, east elevation. Like much of the woodwork on the building, the paint on the sun porches is in poor condition. All of the painted surfaces need to be prepped and refinished with a high-quality paint system that includes priming areas of bare wood along with two top coats of finish paint.*

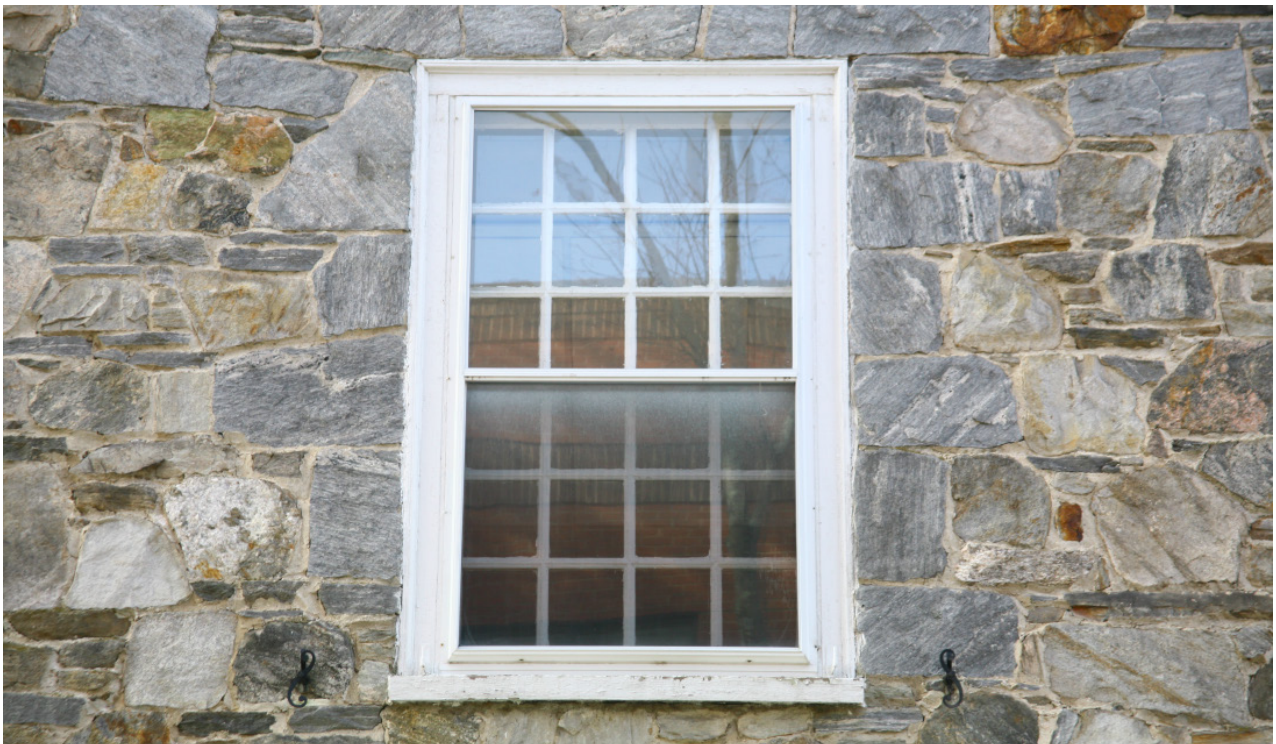
*Fig. 42 Typical 12-over-12 divided-light wood window found in the building. The wood windows are character-defining features of the building and should be repaired and retained throughout. The existing storm windows are at the end of their service life and should be replaced with high-quality, low-profile storm windows. Notice the holdbacks mounted in the masonry on either side of the window for the shutters.*

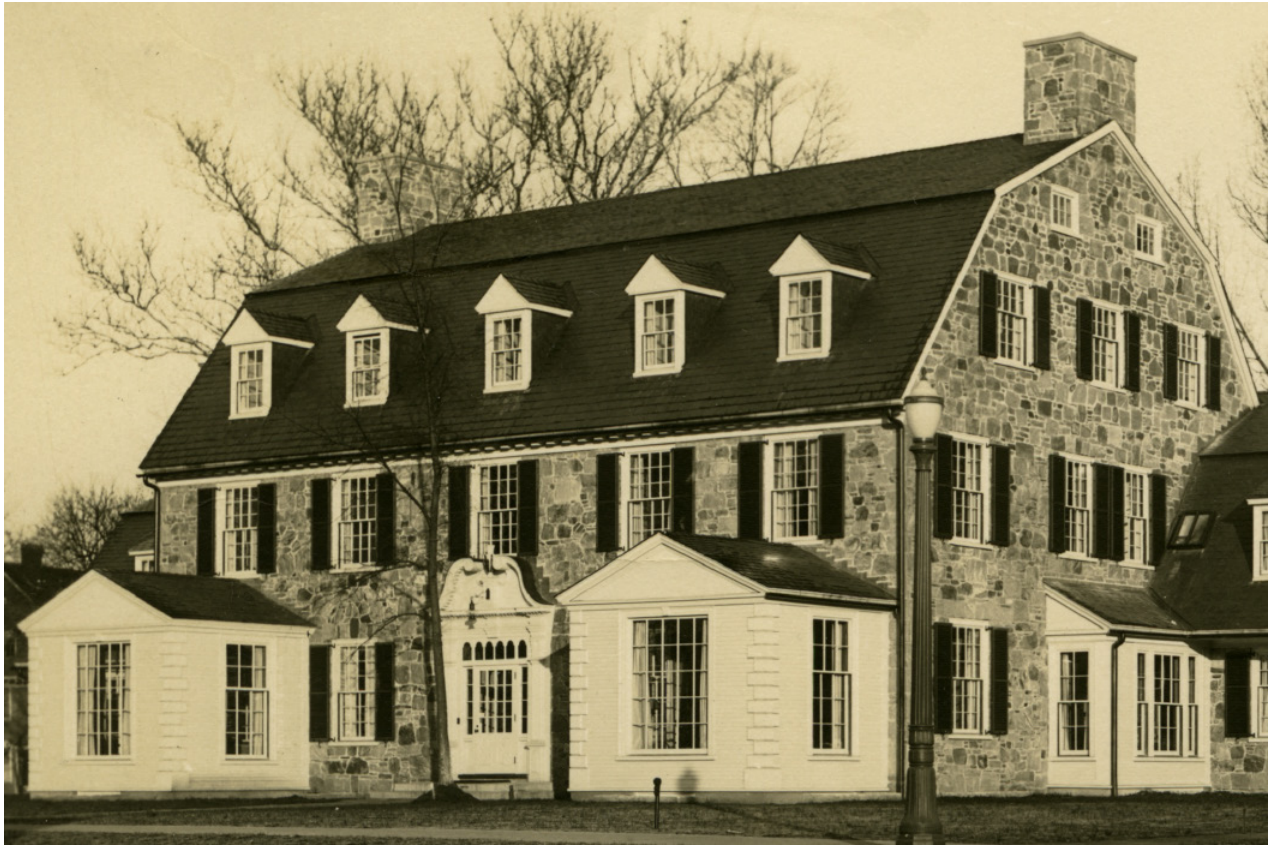
*Fig. 43 The library shortly after completion, showing the wood shutters flanking the window openings.*

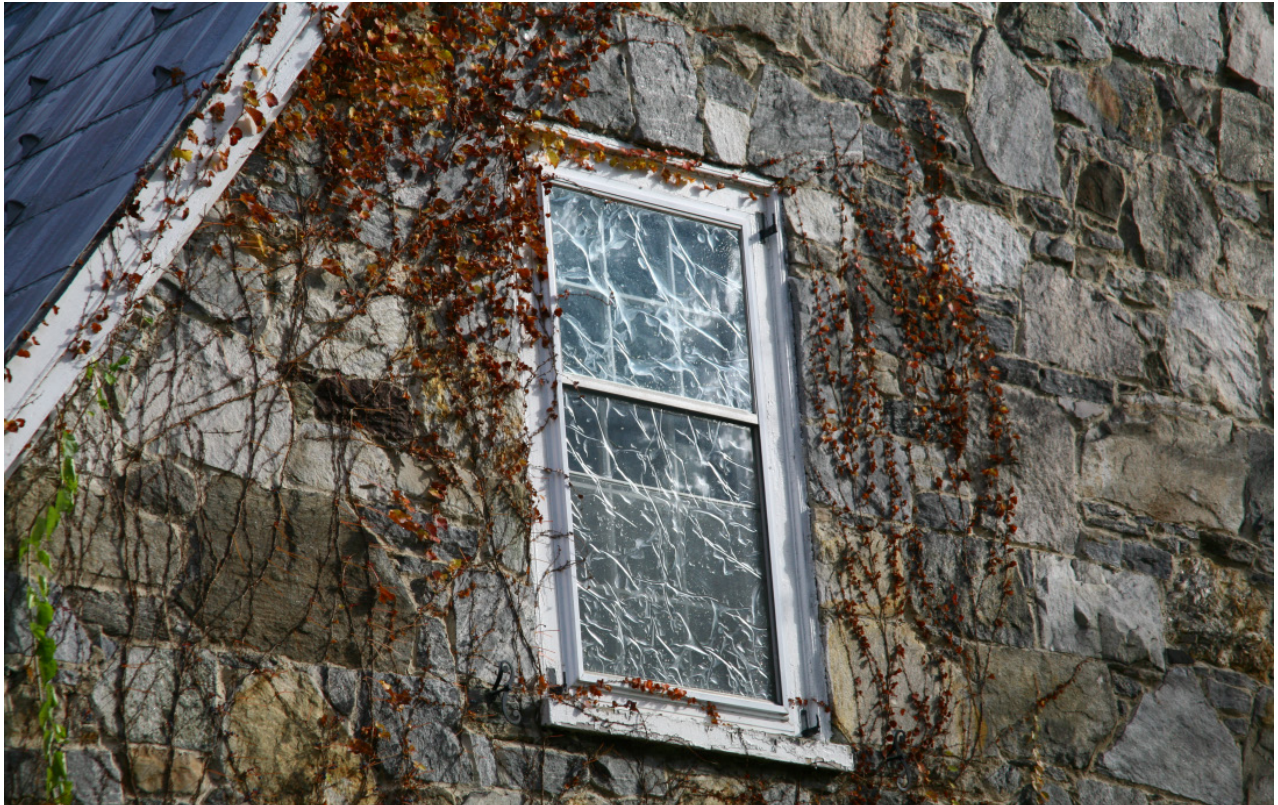
*Fig. 44 Many of the storm windows on the third floor of the library have had UV-protective film applied to them. The film is well past its service life and is now bubbling and peeling from the surface of the glazing. Owing to the age and quality of the storm windows, it makes the most sense to replace them with a high-quality, low-profile storm windows.*

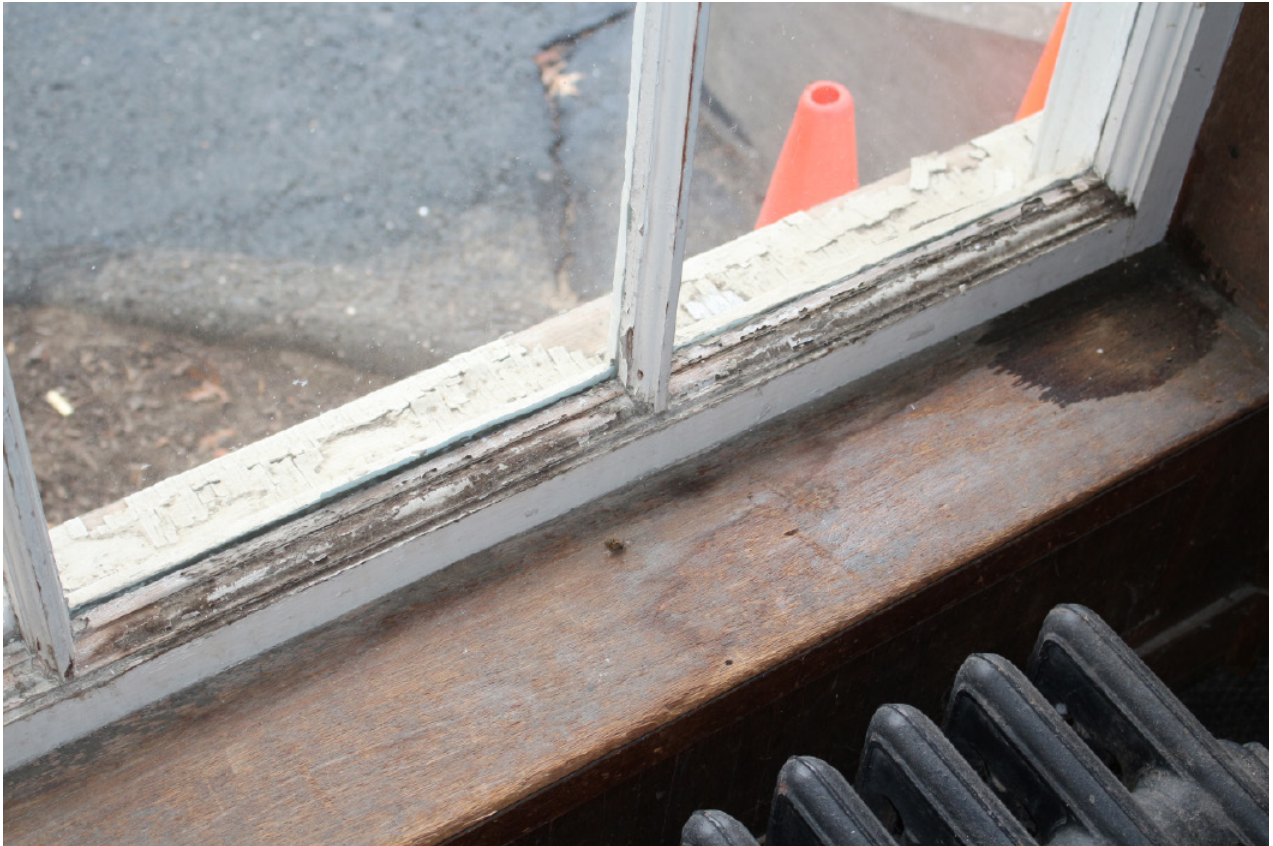
*Fig. 45 Representative examples of failing paint on the window sash and water-stained sills. These conditions are typically the product of condensation that forms on the window glazing and eventually drips down onto the sash and sills. The sill also looks to be dried out due to failure of its clear coat and decades of UV exposure.*

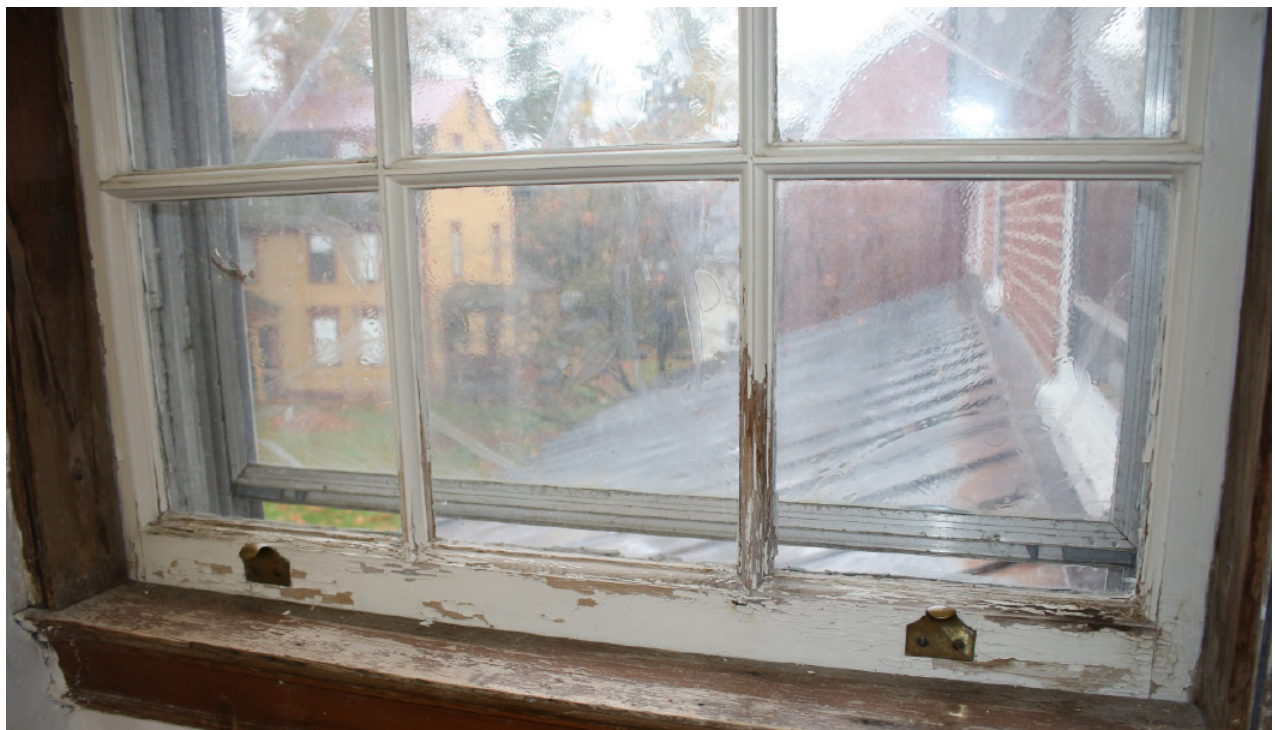
*Fig. 46 West wing, second-floor north window. This window exhibits the typical failures seen from condensation and UV damage. The window is situated in what appears to be a problematic location, where the upper roof discharges rain and snow onto the lower roof (seen through the window). Being the north side of the building, it likely holds moisture and snow longer than elevations that receive direct sunlight.*

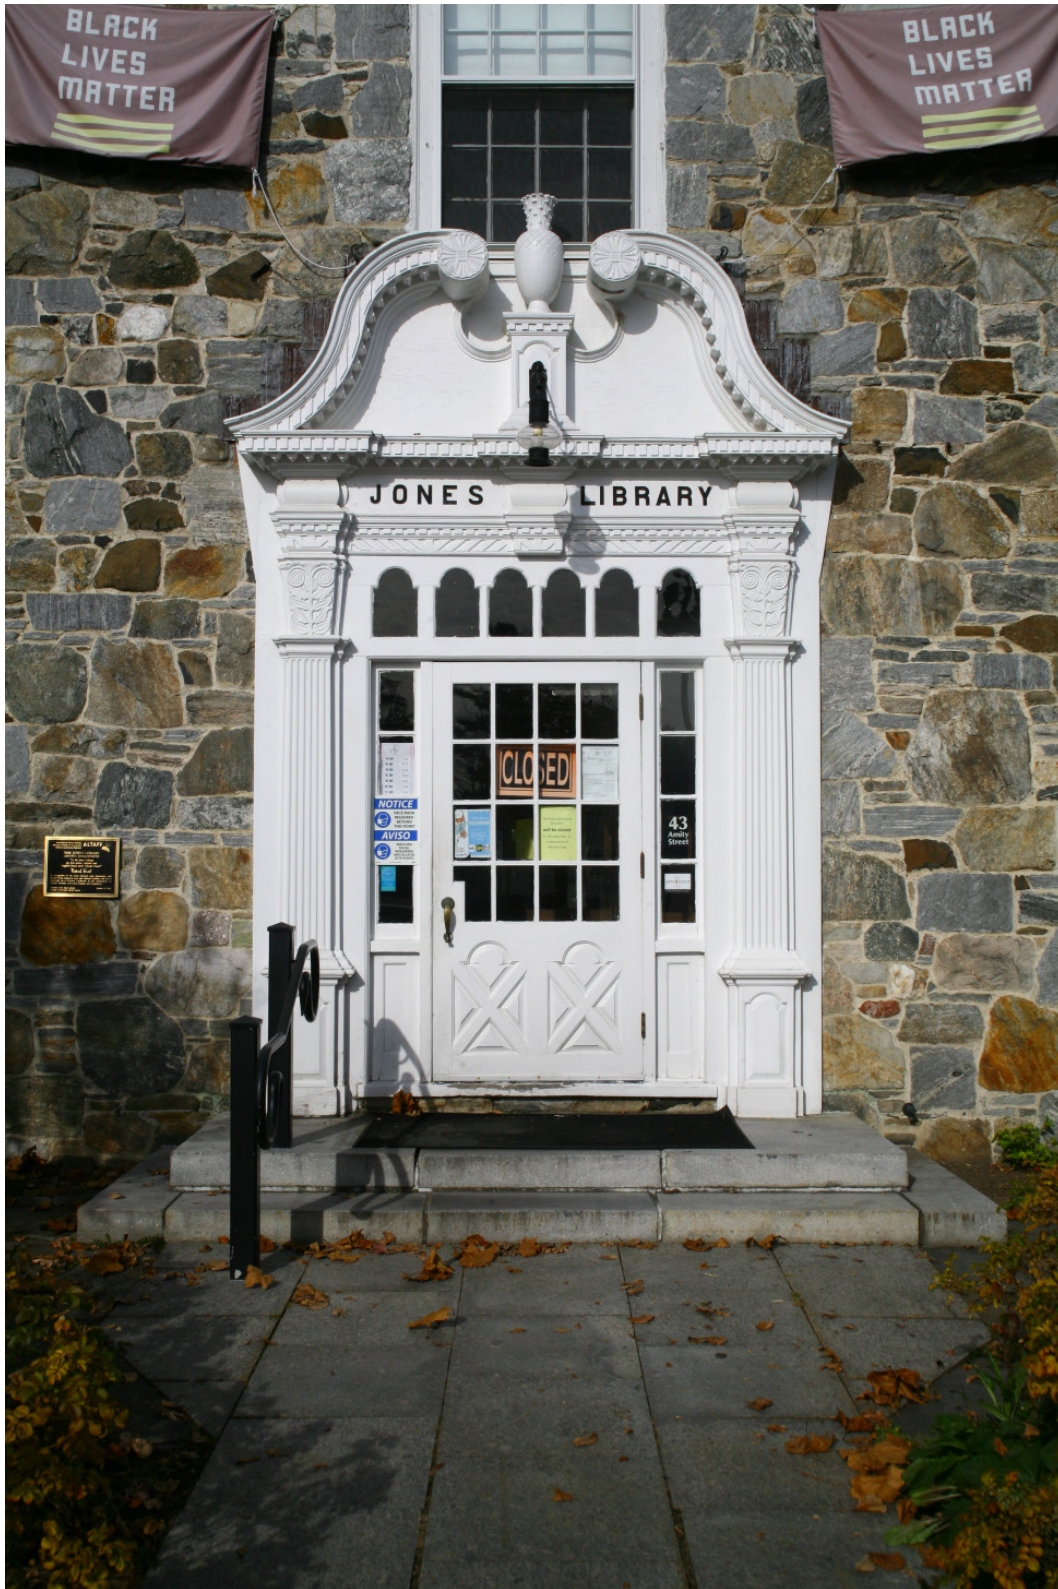
*Fig. 47 The frontis at the south entry is based on Connecticut River Valley door surrounds popular during the mid-eighteenth century. These door surrounds drew from classical examples illustrated in English architectural treatises and found in urban areas along the coast; however, they employed architectural details and proportions unique to the valley. This twentieth-century adaptation takes the design one step further, incorporating a single glazed door and sidelights into the design. Note the carvings in the capitals and the pineapple feature in the center of the scroll pediment.*

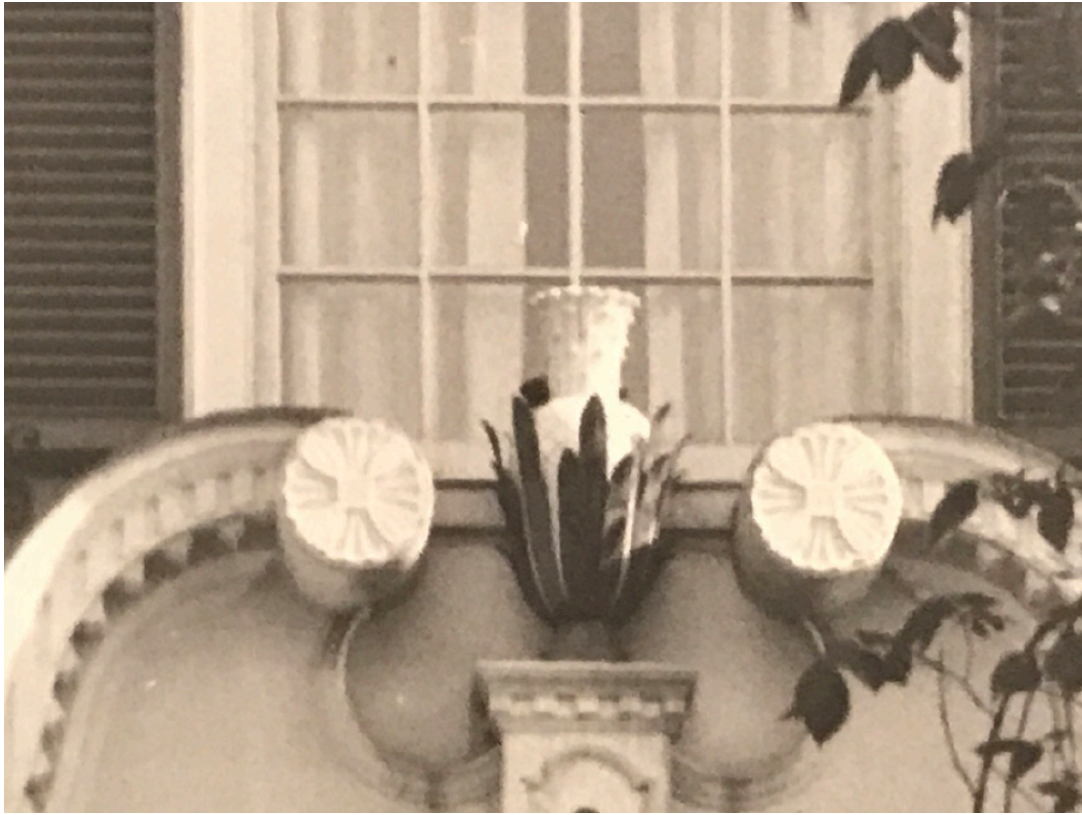
*Fig. 48 Detail of the pineapple located in the pediment of the frontis. Note the leaves surrounding the body of the fruit. These may have been made from some type of sheet material, such as tin or copper, and gilded.*

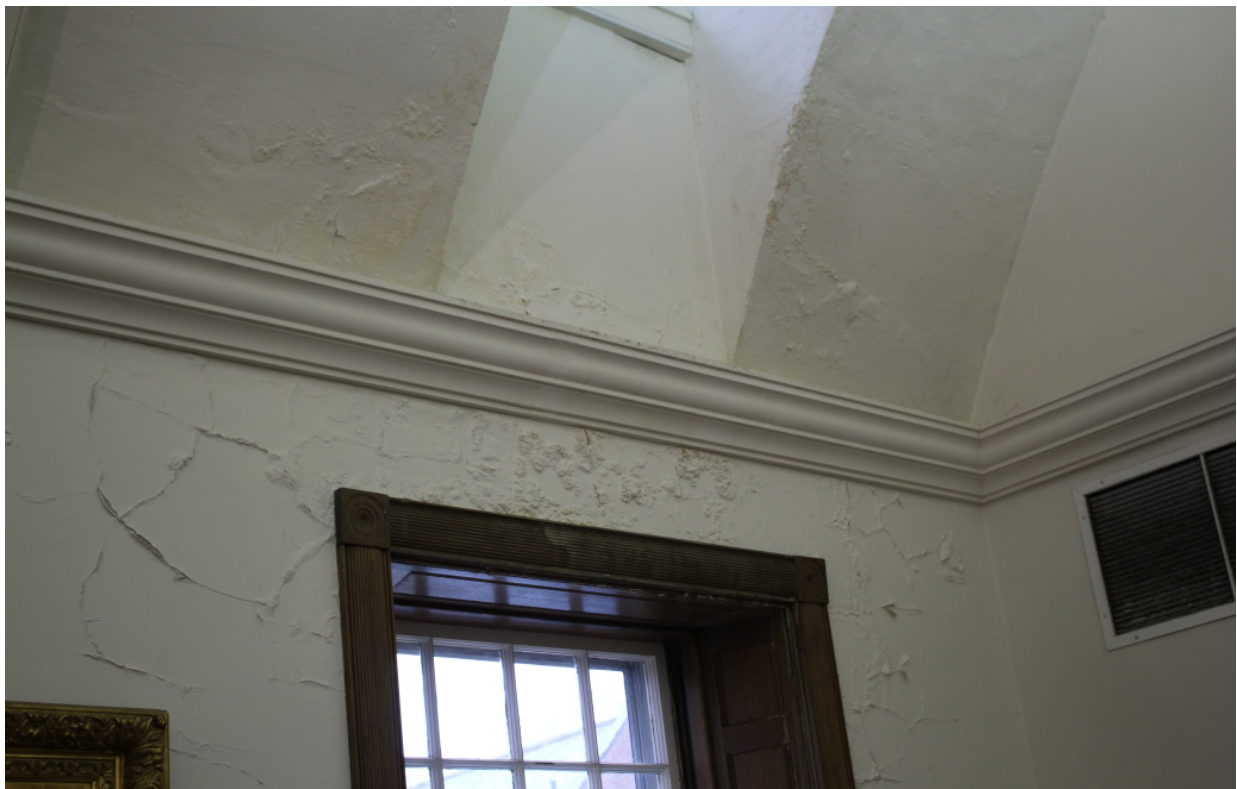
*Fig. 53 Southeast corner of the former auditorium. Past water infiltration has caused the gypsum plaster finish to bubble and deteriorate. This in turn has caused the paint finish to fail as well. This is representative of the plaster surrounding many of the dormers and is likely the result of roofing issues.*

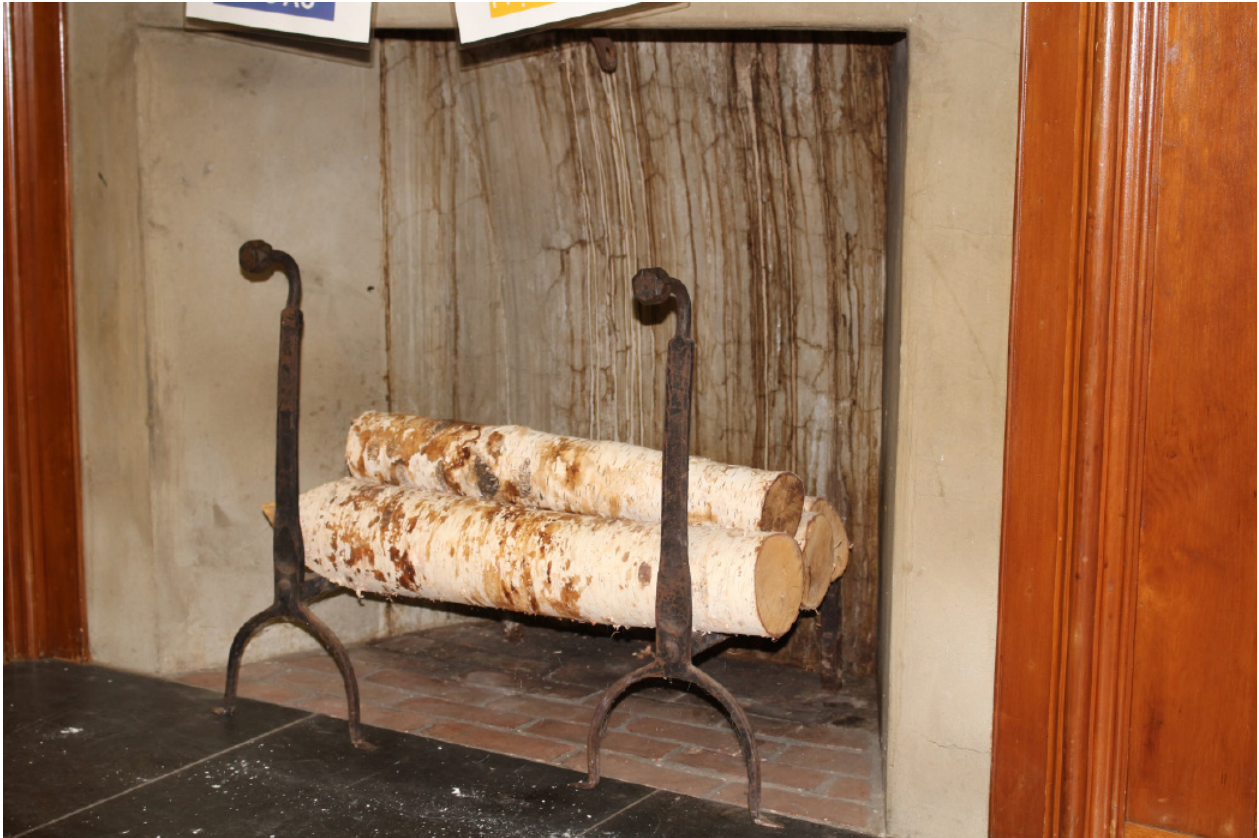
*Fig. 54 West wing, second-floor fireplace. Note the water stains in the firebox and at the rear of the hearth. The white debris on the hearth extension is paint and plaster dust from the ceiling above. This location should be monitored to determine the status of water infiltration. The chimney here should be capped if it is not already.*

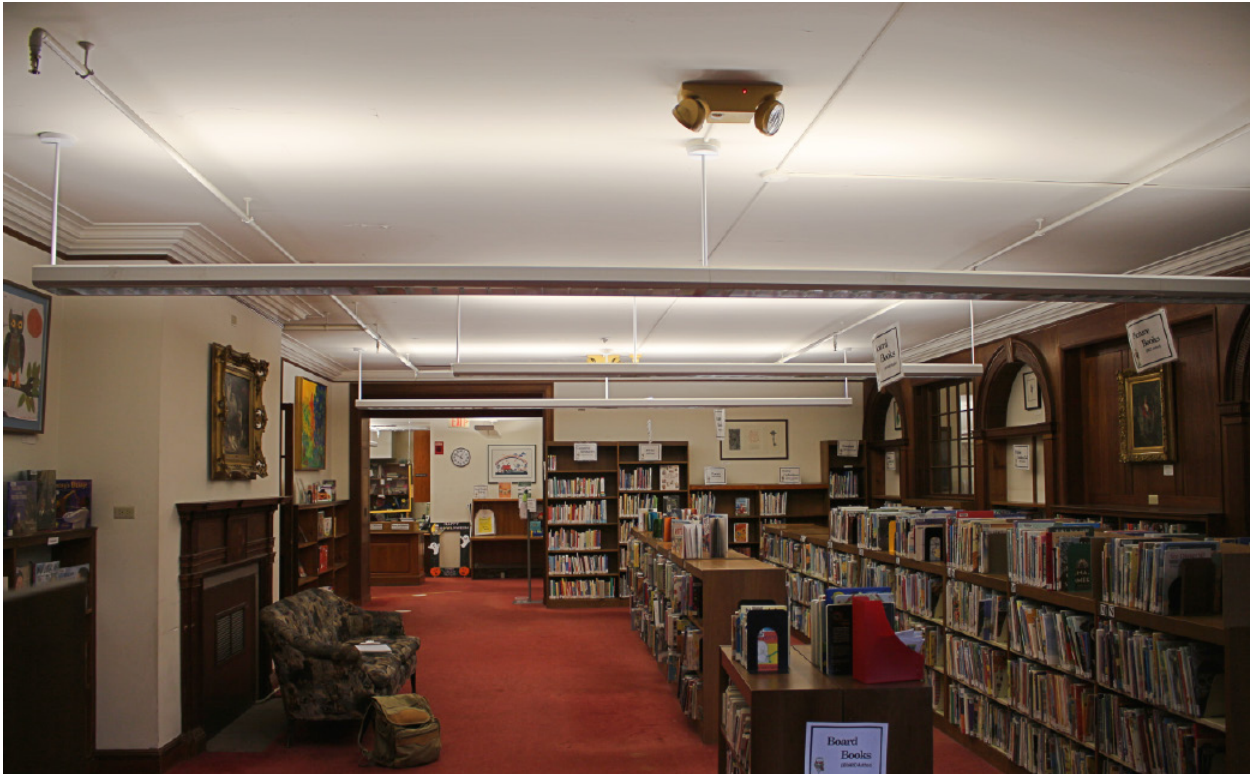
*Fig. 55 Children's stacks. This representative example of incremental change shows how the introduction of things like modern lighting, fire detection and suppression systems, emergency lighting, mechanical systems in the fireplace, and modern paint colors and carpeting has radically changed the original architectural design and feeling of the space.*
